Inventory of Trees About Proposed Cell Tower at: 2591 Lerwick Road, Courtenay, BC

September 24, 2021

Assignment

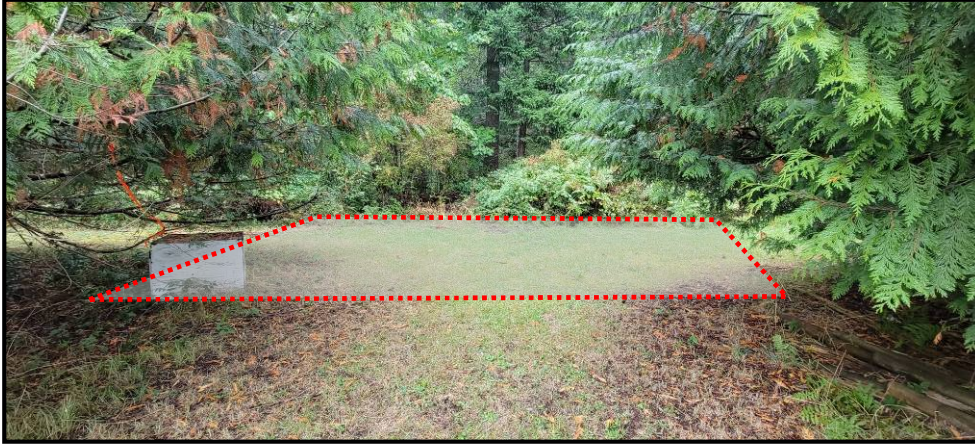
Photo 1. North-west view of location of proposed cell Tower (Tree # 202 at picture left).

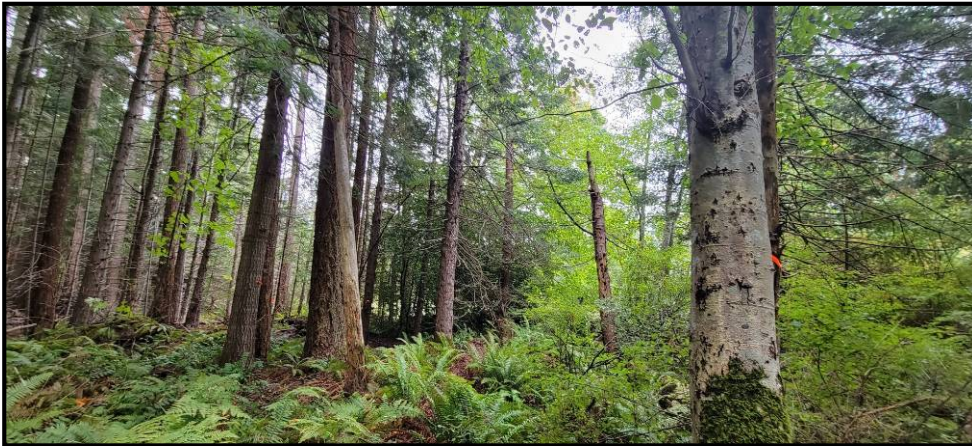
Photo 2. East view of north part of Park assessment area (Tree # 222 at picture right).

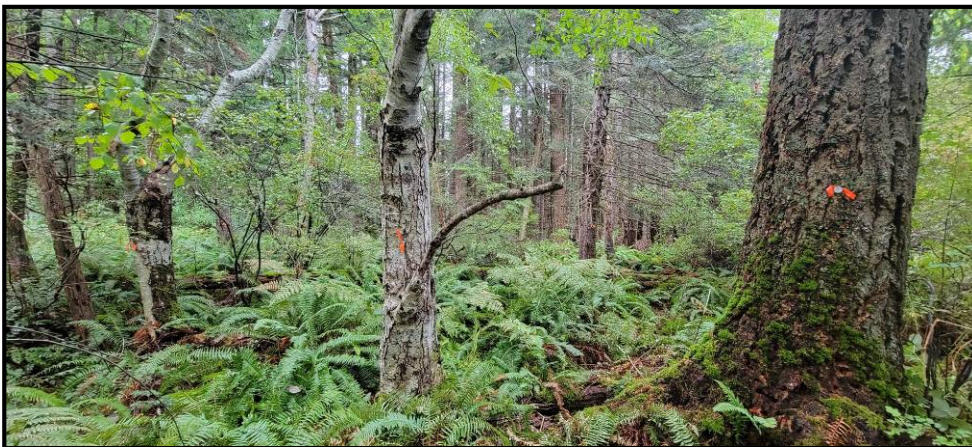
Photo 3. North view from near Property boundary of central part of Park assessment area (Tree # 217 at picture centre).

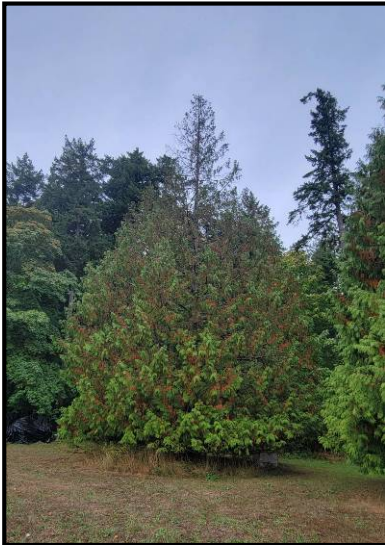
Photo 4. North-west view of Tree # 202.

- # 202 This maturing western red-cedar is located within the Property, immediately south of the proposed Tower's gravel pad. The tree is showing signs of a lack of vigor and is in declining health, evidenced by a sparse foliage, particularly in its upper crown. The Proposed gravel pad will significantly impact this tree's rooting area, and the tree's limbs will interfere with the Tower's hardware if/when it grows in size. The Property owner has expressed an interest in removing this tree to facilitate the Tower installation project (See *Photo 4.*).

Recommendation: Cut this tree to facilitate the Tower's installation.

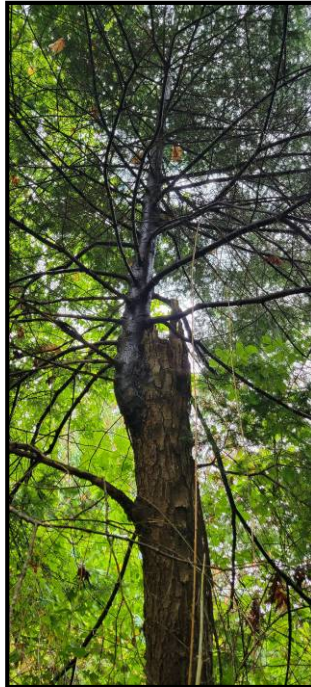
Photo 5. Tree # 210.

- # 210 This maturing grand fir is in poor condition with a previously failed stem at 5.0m above grade and a regrown top attached to the decaying upper stem. The tree has a current risk rating of *Low*, but as it grows in size and the stem decay progresses the risk rating will become *Moderate* or *High*. The tree is 6.0m from the Tower's pad and could target the Tower should it fail (See *Photo 5.*).

Recommendation: Cut this tree now to a wildlife stump to prevent future hazard to the Tower.

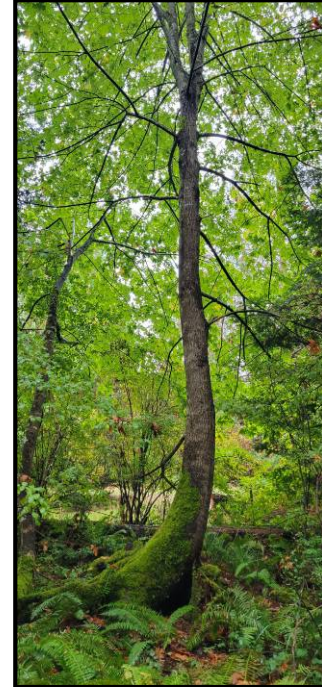
Photo 6. Tree # 213.

- # 211 This maturing Douglas fir is in good to moderate condition.
- # 212 This recently dead grand fir with stem decay will likely lose its top before it fails from the base and is a *Low* hazard to the tower.
- # 213 This maturing bigleaf maple has a non uniform stem base, a regular branching structure, an old corrected lean to the south and would strike the Tower if it failed to the east from root or lower stem failure (See *Photo 6.*).

Recommendation: Monitor this tree for structural stress at its base, and cut to a wildlife stump if it becomes a hazard.

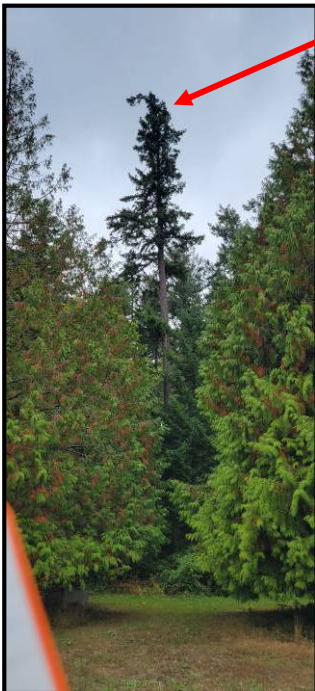
Photo 7. Tree # 215.

- # 215 This mature Douglas fir is the closest large tree to the proposed Tower. It is displaying a loss of vigor with a bent top, slight resinosis at 1/3 height and a very compact/small crown. The tree has a slight stem kink at ¼ height and a slight lean to the west (away from the Tower). The tree has a current risk rating of *Low* (See *Photo 7.*).

Recommendation: Monitor for signs of further biological decline, and cut to a wildlife stump if the tree's risk rating rises to *Moderate*.

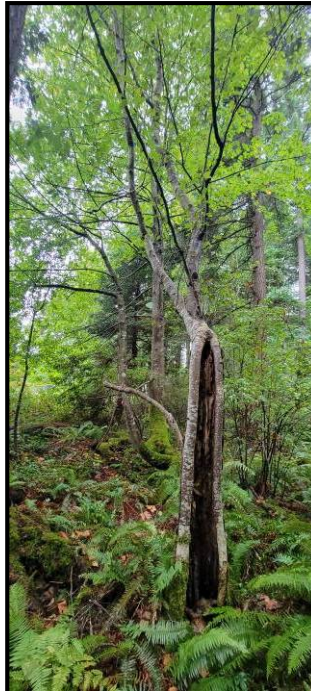
Photo 8. Tree # 217.

- # 216 This maturing Douglas fir is in good condition as is located 1.0m from the Tower's pad.
- # 217 This maturing red-alder is in poor condition with advanced stem decay. It will likely shed its limbs before its stem fails. The tree has a risk rating of *Low* at this time, but it may become *Moderate* if the tree grows significantly in size (See *Photo 8.*). **Recommendation:** Monitor, and cut if the crown later targets the Tower.

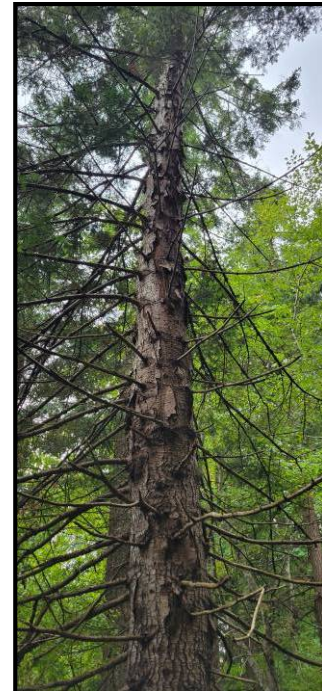
Photo 9. Tree # 224.

223 This maturing grand fir is in poor condition with possible mid-stem decay and poor vigor. It is 10.0m from the Tower's pad and has a current risk rating of *Low* (See *Photo 9*.).

Recommendation: Monitor this tree, and cut later if its risk rating rises.
