Tree Management Plan for Proposed Housing Development at 2700 Mission Road, Courtenay, BC

This Tree Management Plan is intended to address Arborist Reporting requirements as listed in the City of Courtenay Bylaw #2850 in support of the Application for Tree Removal Permit.

2021-09-02 2700 Mission Rd Tree Location Map

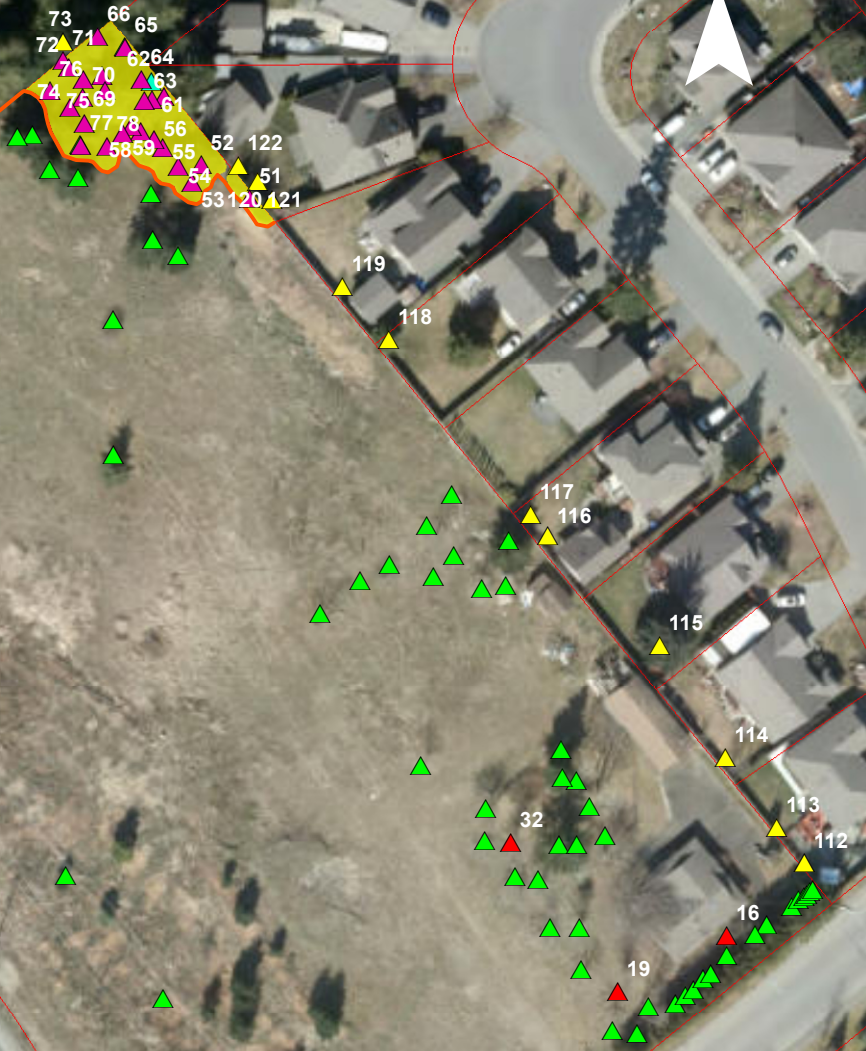
Total counts for the trees within the tree management area are indicated in Table 1 in this report. Area distribution for previously planted trees and proposed tree removals are indicated in Map 1. attached to this report.
