- Lot "A" -  
Revised Application for Rezoning

*Tree Inventory and Assessment*

# **Tree Inventory and Assessment at Lot A Copperfield Rd. Courtenay, BC.**

**Date: Jan 24, 2017**

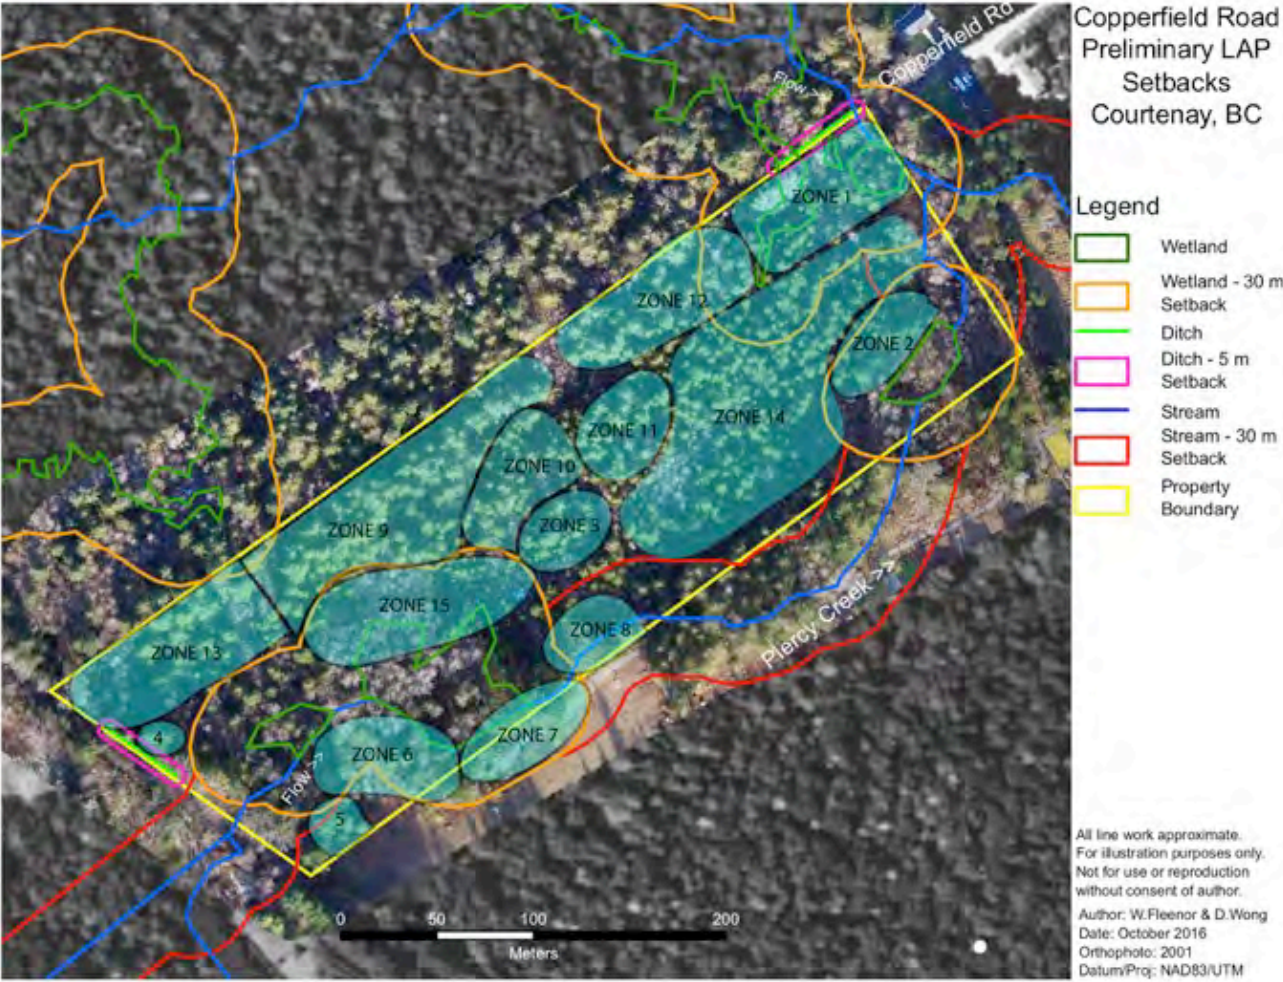
Appendix B: Lot A, Preliminary LAP setbacks by Current Environmental Ltd. with updated forest cover layer and tree stand zones.

Stand of young mixed Cedar and Douglas Fir (*Pseudotsuga menziesii*) with occasional Sitka Spruce (*Picea sitchensis*). This area is located within the wetland and creek buffer. Good health and condition of the stand with no evidence of disease. Trees are 20-25m tall with 25-60cm dbh's. Density of approx 300/Ha

Grove of Douglas Fir trees which likely straddle the property boundary with Arden Road Park. Trees are 48, 56, 75, 48, and 72cm dbh. The two trees closest to the fenceline have had their canopies thinned and were climbed using spurs as evidenced by gaff wounds. This area is located in the SW corner of the property and outside the 30m buffer for Piercy Creek.

Stand is a mix of Alder and Cedar with a few Douglas Fir trees. General health of the stand is satisfactory with no significant hazards. Some cedar exhibit chlorosis and declining upper crowns. Some alder are also showing signs of decline.

This stand is located outside the south property boundary and inside the 30m buffer of Piercy creek. This stand is predominantly young cedar trees (25-60cm dbh) exhibiting chlorosis but also mixed with some Douglas Fir trees (28-45cm dbh) exhibiting poor stem taper and poor live-crown ratios consistent with second growth trees that were dense stand grown. Density of approx. 400/Ha.

Mixed Cedar and Bigleaf Maple (*Acer macrophyllum*). Cedar are chlorotic and have declining upper crowns. Maple are also showing signs of decline with some large dead stems present. This size of multi-species impact is likely a result of hydrology changes from clearing and grading the adjacent property. Density of approx. 200/Ha

Variable mixed-age stand of Bigleaf Maple, Fir, and small to medium Cedar. In the middle of the stand is a cluster of three dead Fir trees 25-50cm dbh. Not enough evidence to indicate a root rot center but still a situation that should be monitored for evidence of decline in adjacent trees. Density of approx. 200/Ha

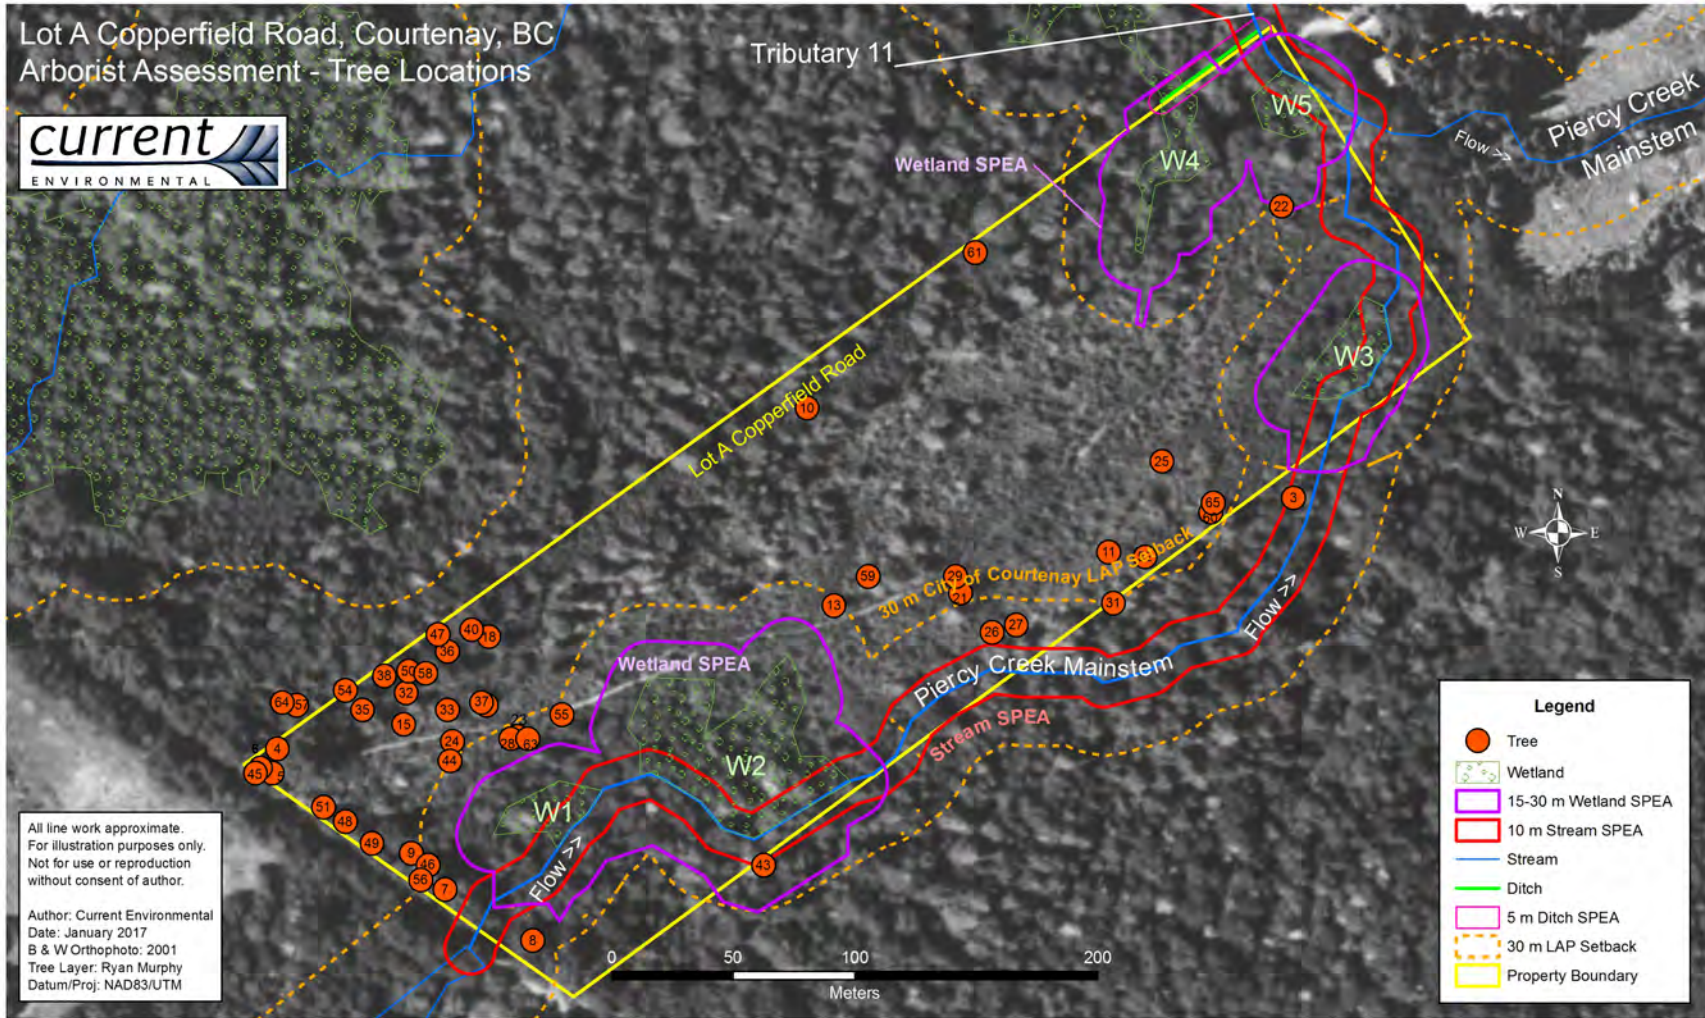
Appendix C: Lot A, Preliminary LAP setbacks by Current Environmental Ltd. with individually surveyed and described trees.

9	Act	92	5503474	354354	35 m tall. Healthy crown.	42	Fd	55	5503469	354499	
10	Mb	130	5503657	354517	Large maple with healthy crown (some dead wood). Good structure. Good feature tree.	43	Fd	70	5503469	354499	
11	Mb	65	5503598	354641	HAZARD TREE, Codominant stem with large separation. Likelihood of failure CERTAIN. Declining crown.	44	Fd	32	5503512	354370	
12	Cw	36	5503576	354528		45	Fd	33	5503507	354290	Stunted top, health good
13	Cw	48	5503576	354528	48 and 36cm. Good Health.	46	Fd	35	5503469	354361	Healthy crown. In ditch buffer.
14	Cw	28	5503527	354351		47	Fd	48	5503564	354365	Healthy crown.
15	Cw	30	5503527	354351	28 and 30cm respectively.	48	Fd	50	5503487	354327	Healthy fir within ditch buffer
16	Cw	38	5503563	354386	Close group, healthy crowns	49	Fd	51	5503478	354338	Healthy crown, in ditch buffer
17	Cw	49	5503563	354386	Close group, healthy crowns	50	Fd	53	5503549	354353	Healthy crown, slightly sparse

18	Cw	58	5503563	354386	Close group, healthy crowns	51	Fd	55	5503493	354318	30m fir with healthy crown. Within the ditch buffer.
19	Cw	50	5503581	354580	Significant lower stem decay and woodpecker excavation. Poor candidates for retention	52	Fd	58	5503596	354656	
20	Cw	50	5503581	354580	Significant lower stem decay and woodpecker excavation. Poor candidates for retention	53	Fd	59	5503541	354327	
21	Cw	50	5503581	354580	Significant lower stem decay and woodpecker excavation. Poor candidates for retention	54	Fd	59	5503541	354327	Healthy canopy and live crown. On the edge of the property line.
22	Cw	47	5503740	354712	47cm dbh, 22m tall	55	Fd	63	5503531	354416	Very good health and structure. Close to edge of wetland buffer and path.
23	Cw	33	5503522	354398	Thin canopy but healthy	56	Fd	66	5503463	354358	Healthy crown. In ditch buffer
24	Cw	42	5503520	354371	Good health	57	Fd	70	5503535	354307	Outside of property. Healthy crown and structure
