# **Geotechnical Assessment**

**Proposed Hotel  
3070 Kilpatrick Ave  
Courtenay, BC**

December 15, 2008

Project No. SGL08-047

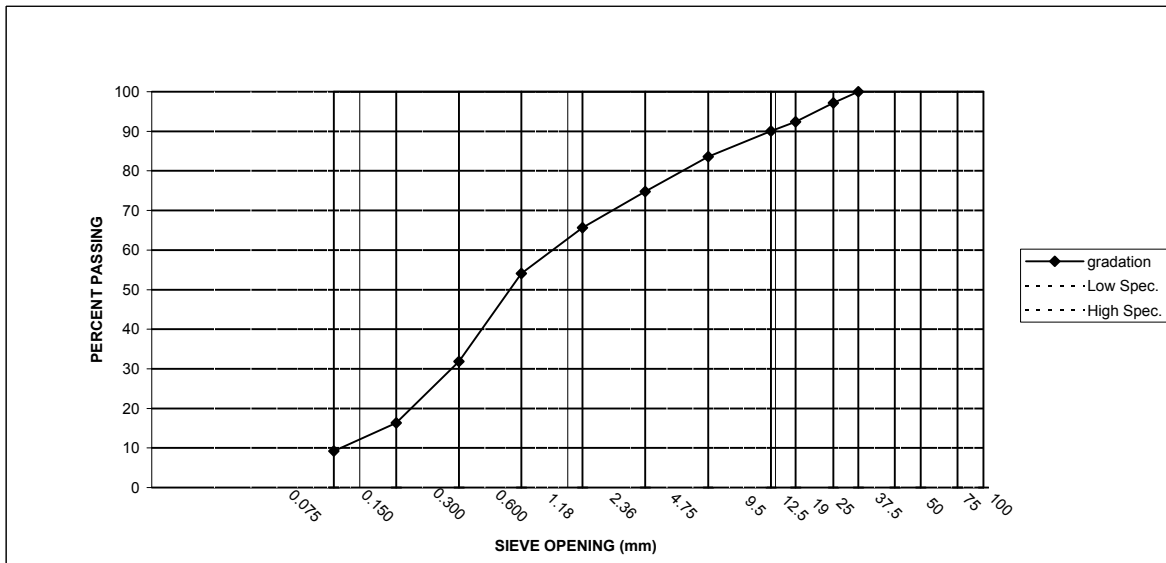
Silt and / or Clay (-0.075 mm): 9.2 %

**AGGREGATE GRADATION:**

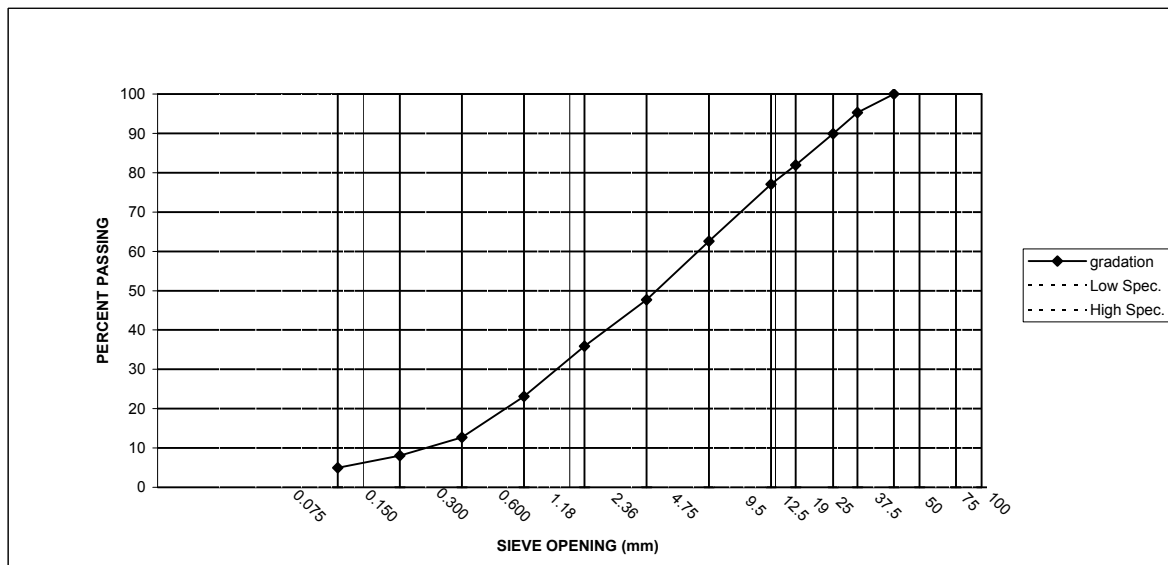
Silt and / or Clay (-0.075 mm): 5.0 %

**AGGREGATE GRADATION:**
