ENVIRONMENTAL ASSESSMENT AND PROTECTION PLAN

1915 CUMBERLAND ROAD

CITY OF COURTENAY, BC

July 5, 2021

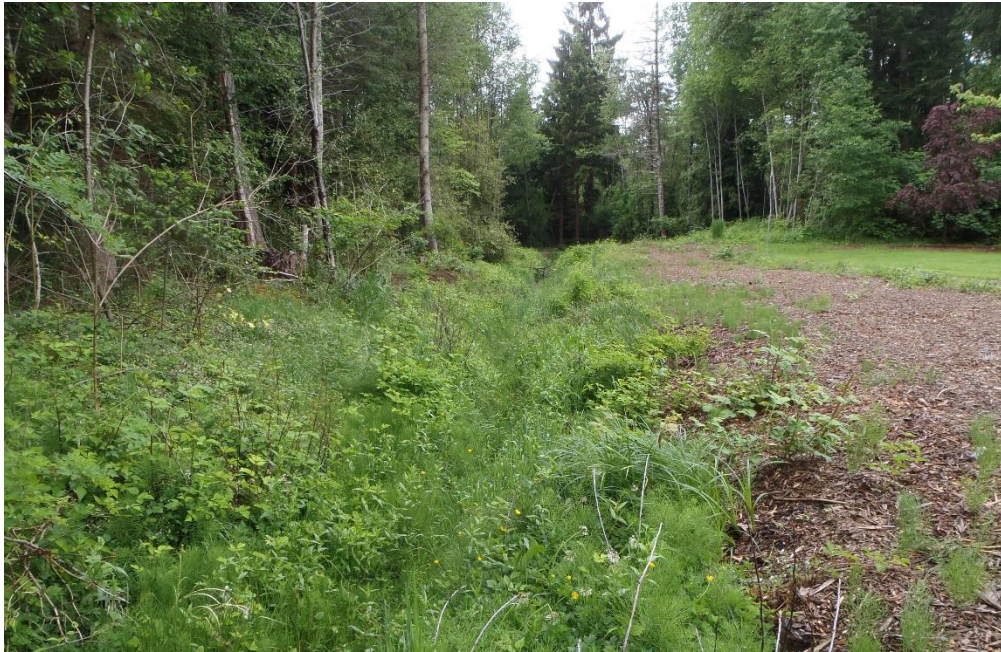
Photo 1. Downstream view (south) of the existing Larsen Road ditch taken from the approximate downstream end of proposed 30 m pipe enclosure showing the ditch that will be retained with a 5 m LAP setback.

Establishing driveway access off Larsen Road will require extending an existing 200 mm dia. PVC storm pipe at the end of pavement on Larsen Road approximately 30 m east, enclosing a portion of non-fish bearing ditch (Figure 1; Photo 1). A recommended natural preservation area included within the development plan includes a 15 m

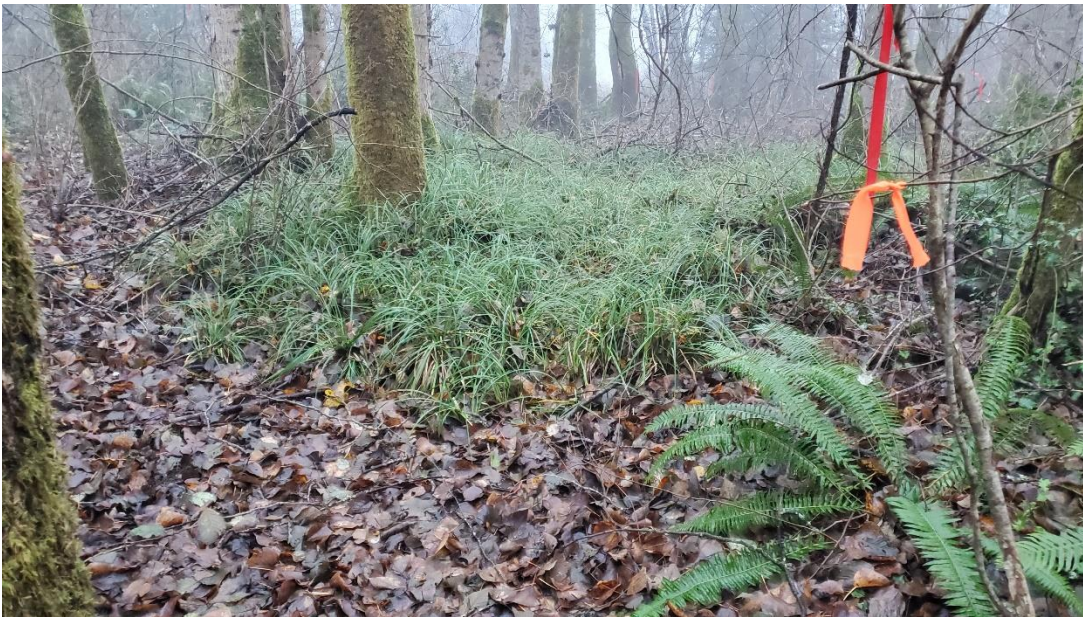
- a. Wet season observed depths are minimal and non-contiguous at 5 cm on Dec. 2nd (Photo 2) (10 cm bankful depth) and are considered representative of a typical winter.

- b. There was no observed connection between the wetland and the nearby non-fish bearing ditch on Dec. 2nd (Photo 2), and it is suspected that the wet depression is present in part because of water impounded by spoilage that appears to have been sidecast onto the edge of the property during establishment of the Larsen Road ditch.

- c. The presence of shallow seasonal water, disconnection from the Larsen Road ditch under most conditions except extreme weather events, and the non-fish bearing status of the ditch show that there is limited value to amphibians and fish in the wet depression's current configuration.

Photo 2. Isolated wet area near the western edge of the property looking east representing winter conditions (Dec. 2020) showing minimal water accumulated and a presence of hydrophytic vegetation.

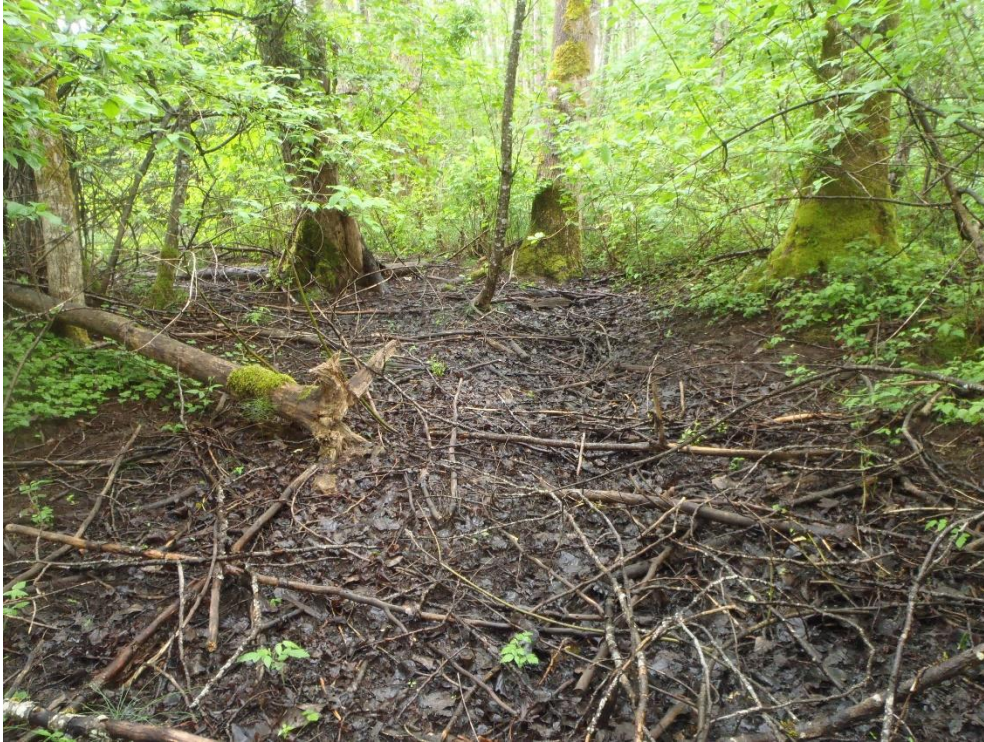
Photo 3. View north of an unvegetated patch of seasonally wetted area connected to the isolated wet area in the western half of the property during spring conditions (May 2020).

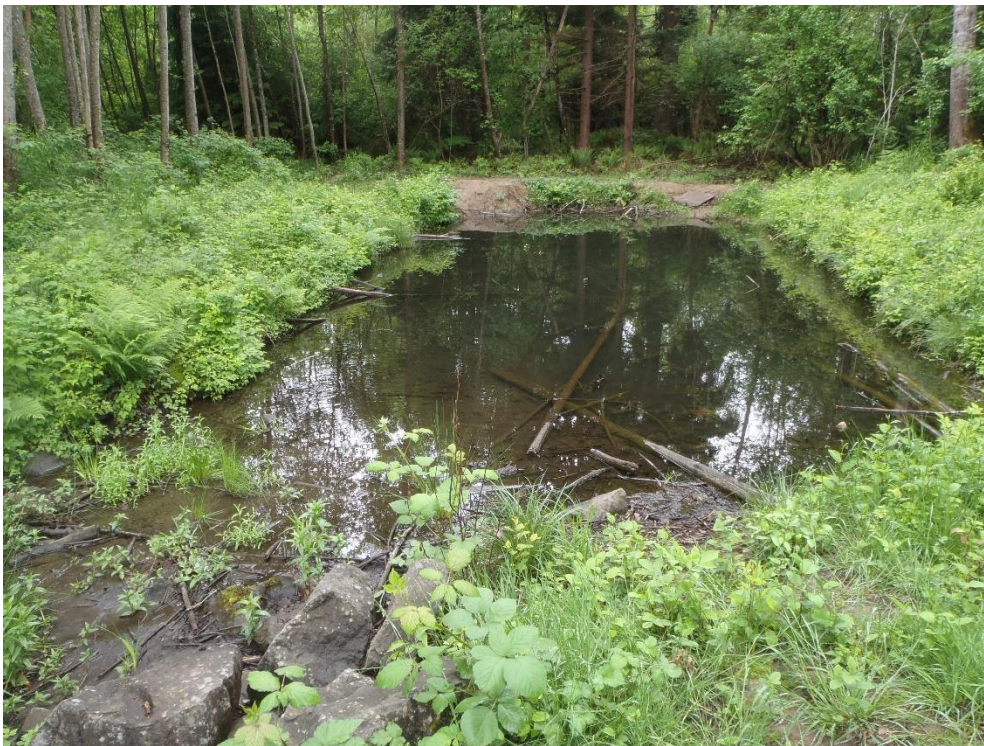
Photo 4. View south of a stormwater pond within the Larsen Road ROW associated with development of the residential area west of the subject lot in the 1990s.

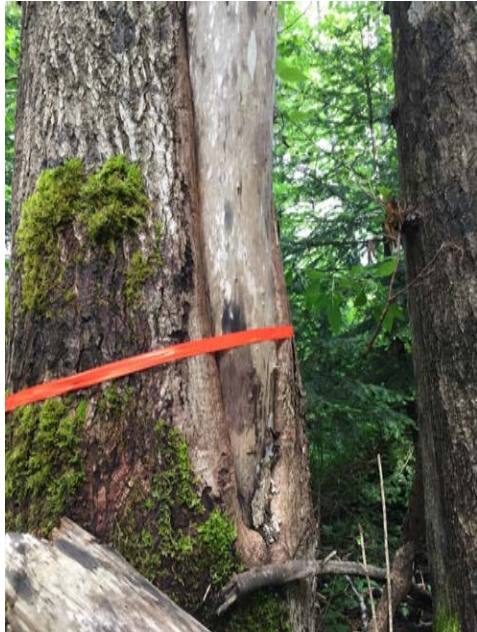
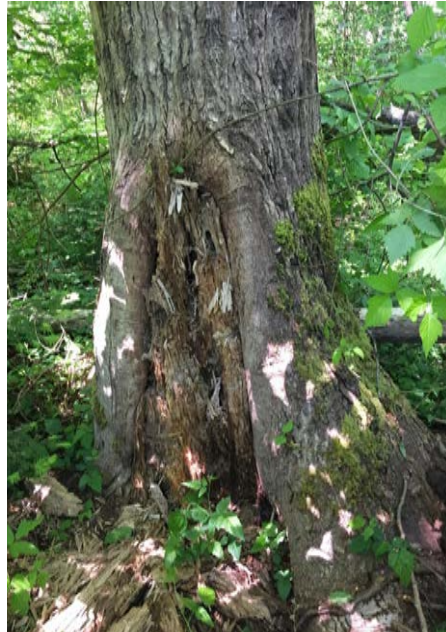
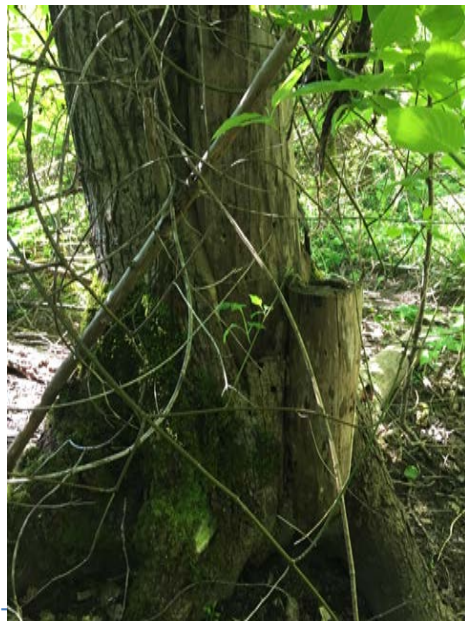
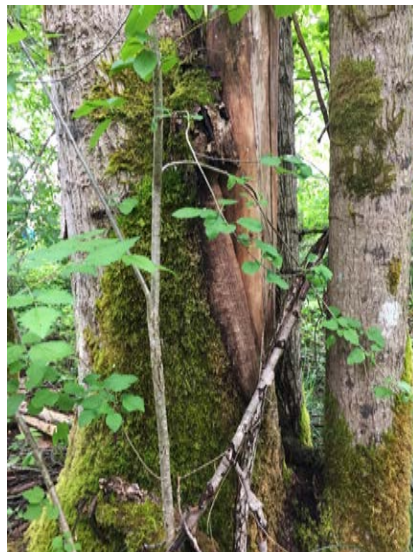
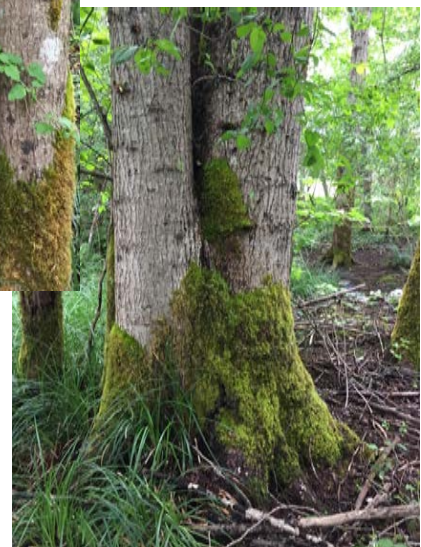
Top Left: 7251
Top Right: 7254
Bottom Left: 7273
Bottom Right
Top/Bottom: 12079

There are several mature cottonwoods along the edge of the buffer zone, particularly tag #s 7251, 7254, 7273, and 12079, that have been recommended for an advanced (Level 3) risk assessment. These mature cottonwoods have evidence of significant basal decay, and conducting an advanced risk assessment will help determine the extent of the decay and whether these trees are viable to retain on the new forest edge. Under current site conditions the lack of targets results in a low risk rating for these trees, but future development activities will change the target profile and increase the risk rating to moderate.

7254	Cottonwood	66	Yes		Moderate	Decay at base, good wound wood around it. Currently low risk but moderate once development activities begin.	Level 3 risk assessment	To be determined
7253	Alder	27	Yes		Low			
7252	Cottonwood	50	Yes		Low

- 9) Provincial Tree Replacement Criteria will be utilized wherever danger trees require removal from the proposed habitat protection area surrounding the Habitat/SW pond in the southwest corner of the site (i.e., mature cottonwoods #7251, 7254, 7273, and 12079 described in the Arborist's Report in Appendix A).
