Assessment of trees > 20cm DBH and protected species located at 310, 320, & 360 Hunt Rd.

Prepared for: Lovick Scott Architects

Date: May 5, 2020

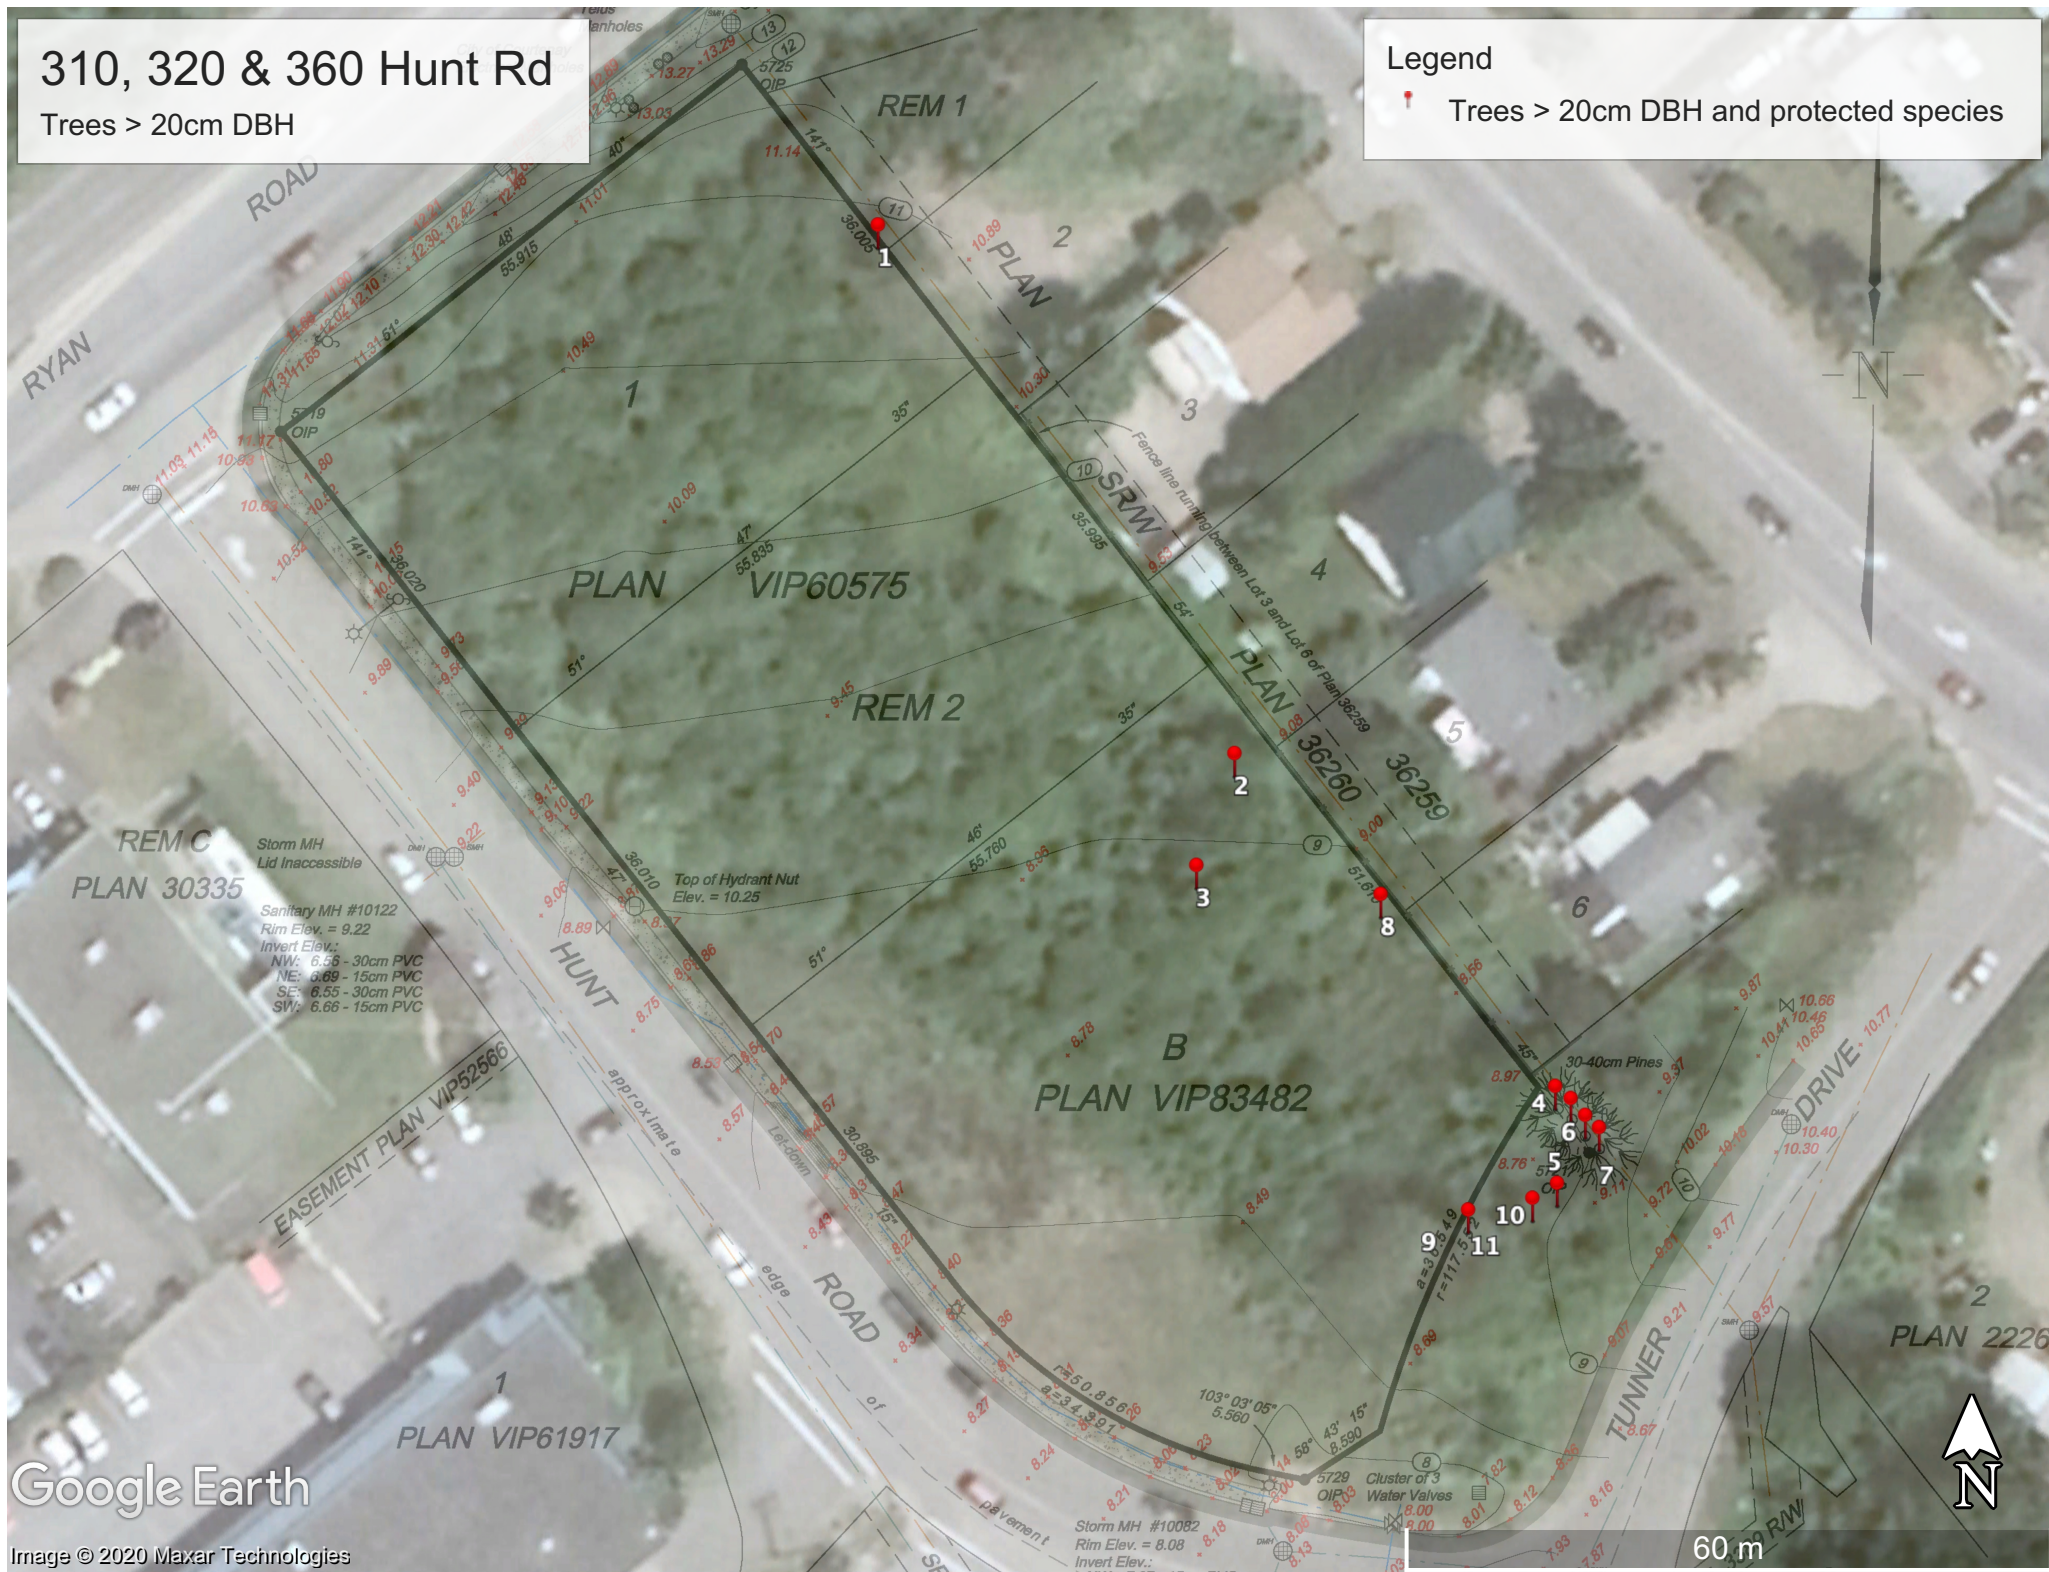
Trees > 20cm DBH and protected species

A total of 3 trees greater than 20cm DBH were identified on site. Additionally, five trees were identified on adjacent properties that may be affected by construction activities (Table 1). Of the five trees identified on adjacent properties, four were the protected species Western White Pine (*Pinus monticola*) located on 'lot' 385. The remaining adjacent tree is a variety of ornamental Cherry (*Prunus serrulata*) located on lot 305. An additional three trees greater than 20cm DBH were identified on the unclassified right of way to the southeast of lot 336.

The three Red alder trees identified on site (2,3 & 8) are in direct conflict with planned infrastructure and cannot be retained. Tree #1 appears to be very close to the property line of lot 310. This tree has a critical root zone of 3.1m and minimum root protection area of 1.8m. With the 0.7m landscape buffer at the rear of the property, this tree will still require a minimum 1.1m of root protection during construction activities.

The four Western white pines (4,5,6,7) located on 'lot' 385 are of moderate concern given the current location of the adjacent proposed entrance road. These trees have critical root zones of 4.2, 2.9, 3.0, and 3.25m respectively with minimum root protection areas of 2.1 and 1.8m. This root protection area will be likely impossible to maintain with the excavation and grading necessary with the current plan. If the city requires the retention of these trees then a change in development plans will be required to preserve the root protection area during construction. It should be noted that given the orientation and spacing of these trees that they were likely planted and not volunteers. All four western white pine also have regrown tops at the same height, suggesting that they were manually topped early in their life. With the regrown tops, and basal stem defects, these trees are only of satisfactory quality for retention.

Once development plans are finalized the root protection area for any trees being retained should be established based on the specifications in Table 1. Prior to clearing and grading these RPA should be established on site with a semi-permanent barrier. A suitable material orange 'snow fence' or safety fence in a 36 or 48" height and erected with sturdy posts that will not be blown over by wind. This will provide a highly visible root protection area that shall not have material removed from, piled in or heavy equipment moved through, or parked on. This barrier should remain in place until all major construction is complete so that any building materials or equipment are not parked or stored in the root protection area. If any compromises to the root protection are agreed upon through the development planning, a certified arborist should be present to supervise any excavation that occurs within the otherwise minimum root protection area.
