Riparian Areas Protection Regulation - Qualified Environmental Professional - Assessment Report

Date June 11, 2020, Updated
May 11, 2021

Street Address (or nearest town)	801 Ryan Road		
Local Government	City of Courtenay	City:	Courtenay
Stream Name	Stream 1, Stream 2, Len's Pond, Bonner Creek, Ditch 1		
Legal Description (PID)	000-887-951 (development), 030-217-784 (Tunner Drive extension)	Region:	Vancouver Island
Stream/River Type	Stream, Wetland	DFO Area:	South Coast
Watershed Code	920-553400		
Latitude	49	41	53.3
Longitude	124	59	07.7

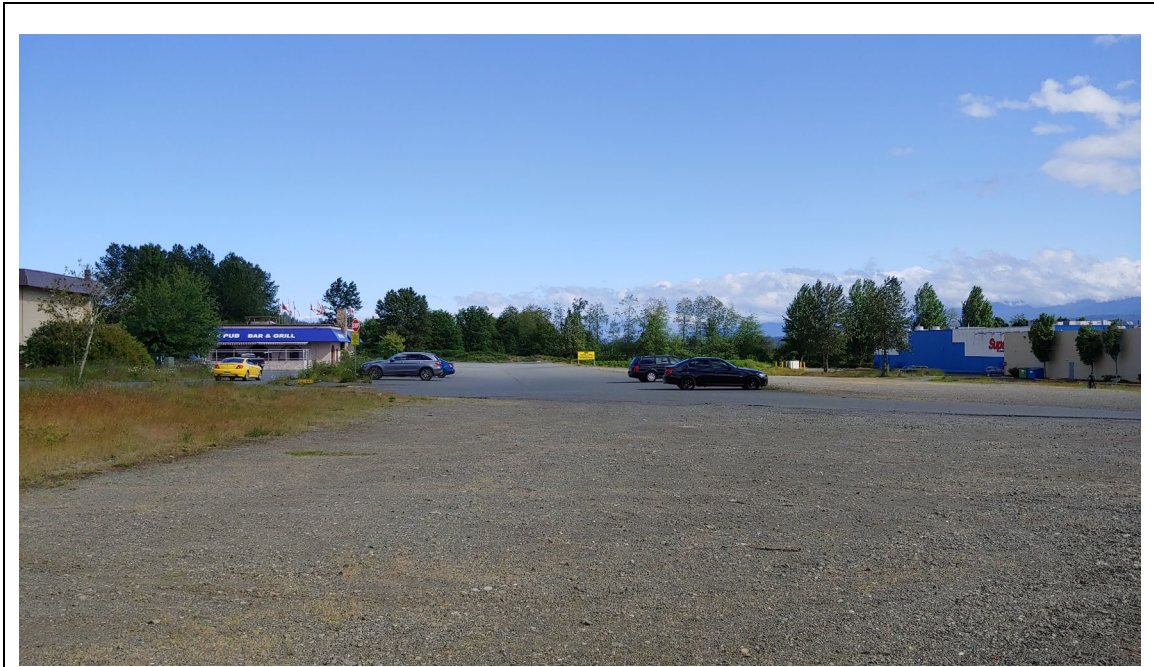
Photo 1. Subject property looking southeast toward berm and Streams 1 and 2. Photo taken near Ryan Road, on northwestern part of property. Paved section seen on eastern side of property and unpaved section seen on western side of property adjacent to Superstore (June 2020).

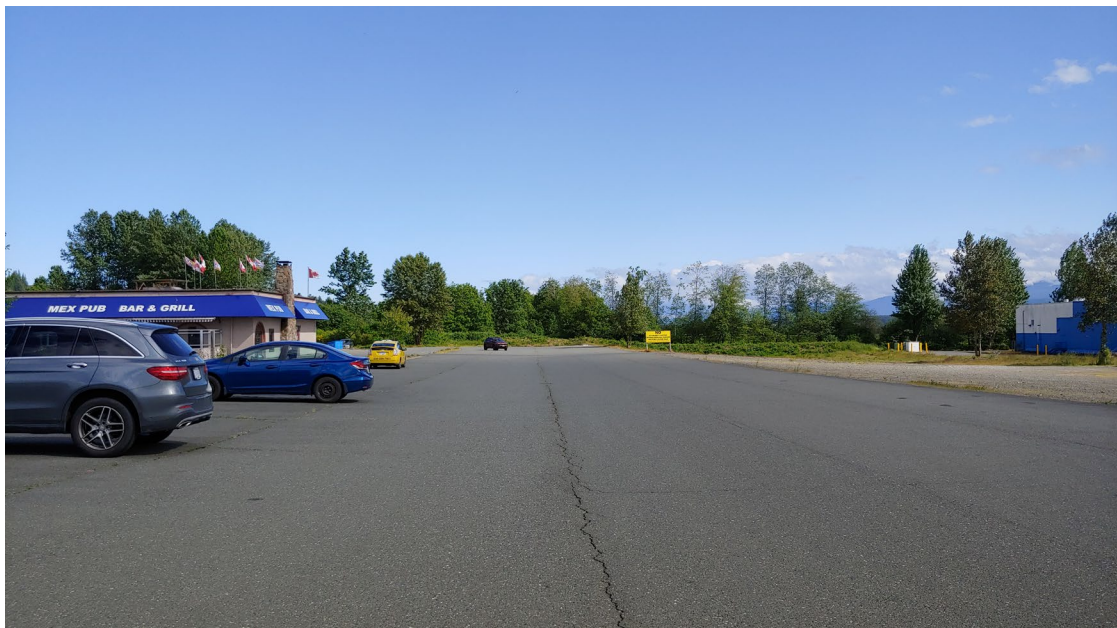
Photo 2. Subject property on paved portion looking southeast toward berm and Streams 1 and 2. Unpaved portion of property on western side adjacent to Superstore (June 2020).

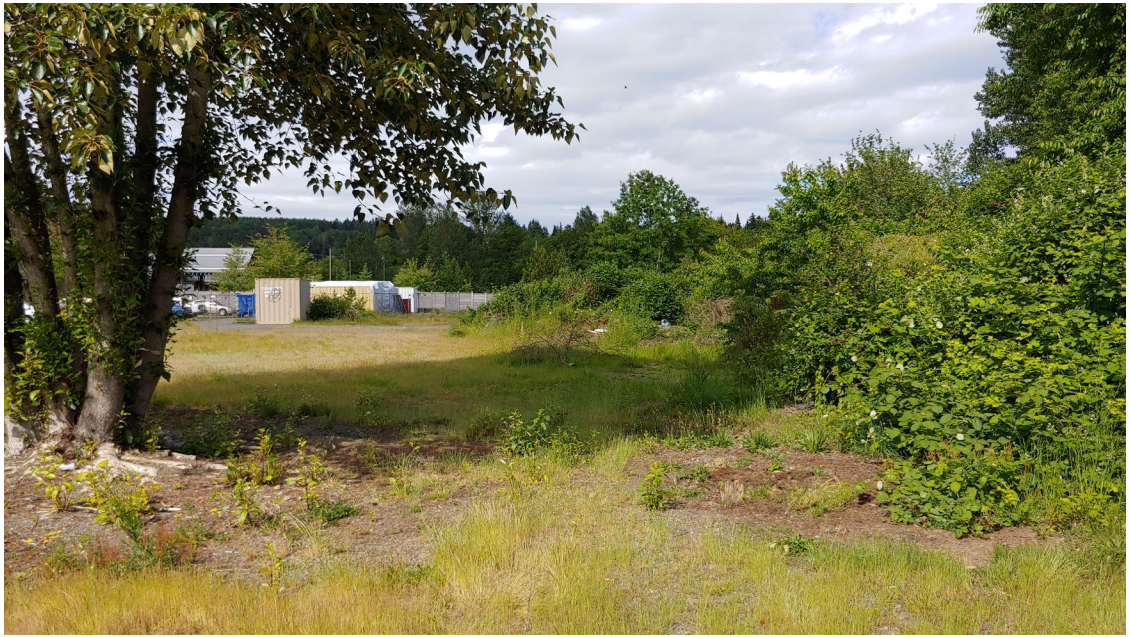
Photo 3. Grassy southeast portion of subject property south of Washington apartments. Mature black cottonwood tree observed in left side of photo and berm with Himalayan blackberry thicket observed in right side of photo (June 2020).

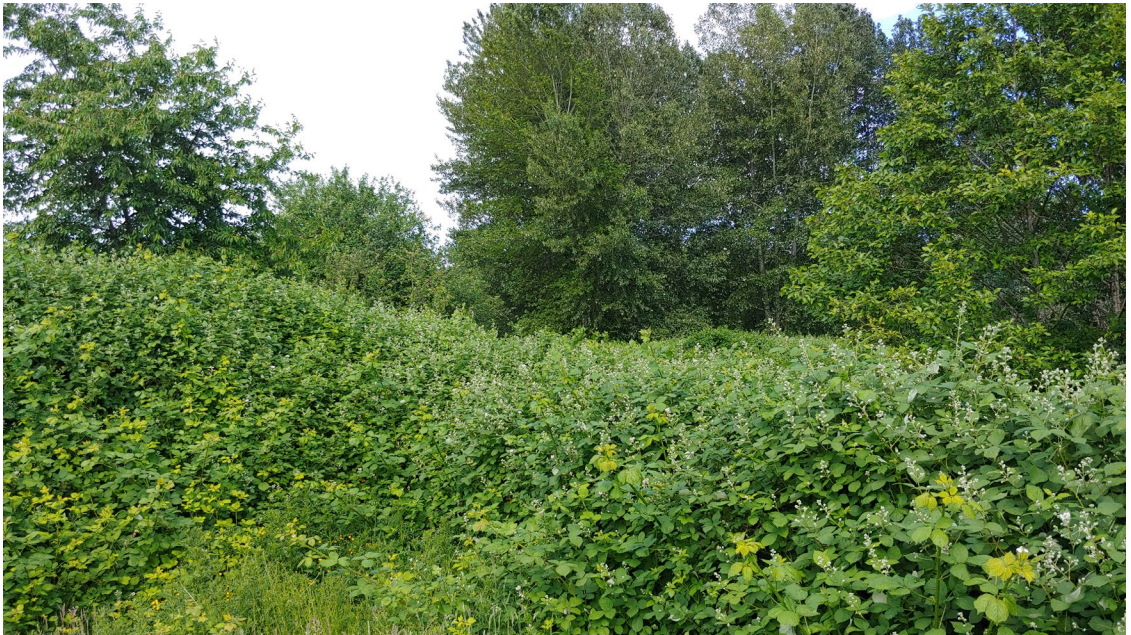
Photo 4. Himalayan blackberry thickets along berm adjacent to riparian area of Stream 1 (June 2020).

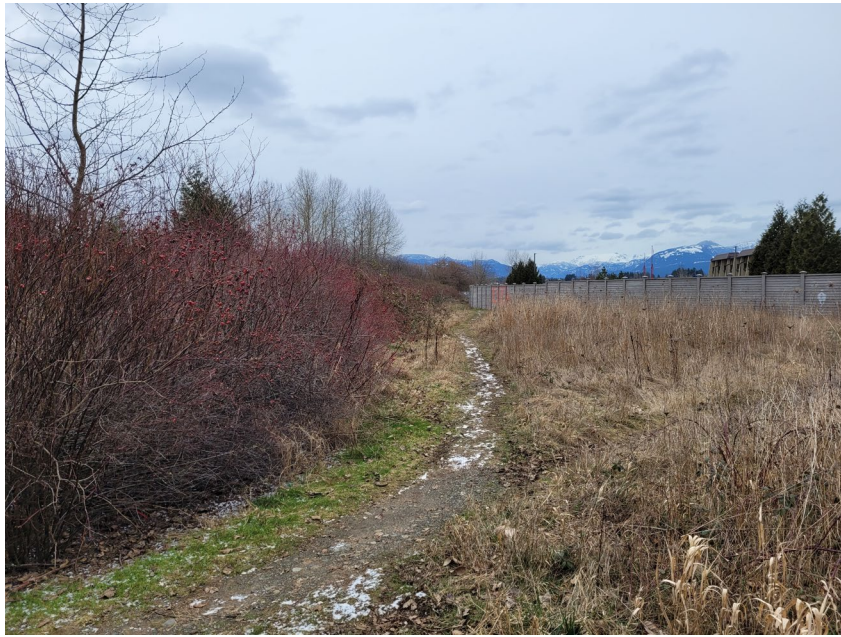
Photo 5. Municipal property to the east of 801 Ryan Road where the proposed Tunner Drive extension will be constructed. Looking southwest, with nootka rose and Himalayan blackberry in the Bonner Creek riparian area (left side of photo) and grasses and invasive species beside the fence (right side of photo; February 2021).

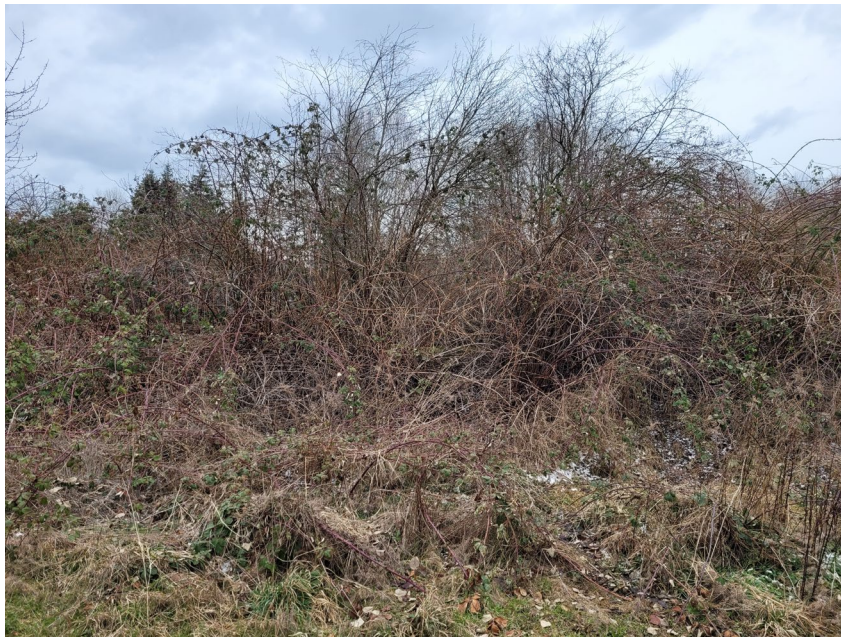
801 Ryan Road is a cleared and empty lot. A small portion of the lot is paved (the southeastern section), while the remaining portion is unpaved (gravel) and dominated by grasses (Photos 1 and 2). Two paved roadways run west from the paved portion into the Superstore parking lot to the west. There is a narrow grassy and unpaved section of the property that extends east, which is located south of the Mexicana liquor store, Mex Pub, and Washington apartments (Photo 3). A soil berm covered in Himalayan blackberry thickets runs along the entire southern length of the subject property (Photo 4). The neighbouring property to the east is owned by the City of Courtenay as a road ROW and is currently undeveloped. There is a fence line to the north of the lot and walking trails throughout the lot (Photo 5). Thickets of nootka rose and Himalayan blackberry are growing between the walking path and Bonner Creek (Photo 6).

Photo 6. Riparian vegetation along Bonner Creek overrun with Himalayan blackberry (February 2021).

Due to the poor quality of the riparian area along Bonner Creek (low species diversity, narrow strip of vegetation, high prevalence of invasive species), we recommend that the 10 m SPEA of the Creek be enhanced with native species planting and invasive species removal to improve the functionality of the riparian zone.

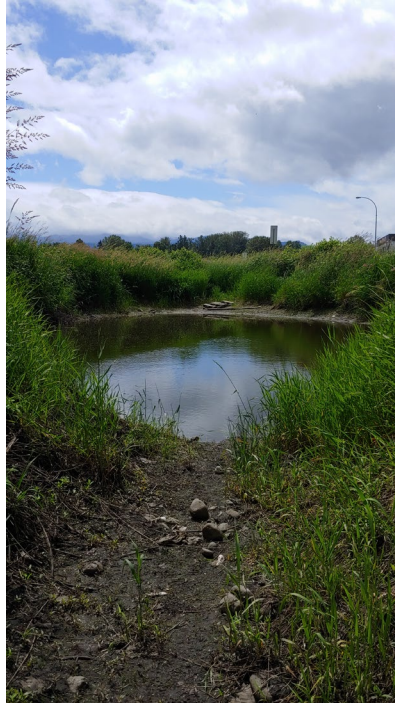
Photo 7. CoC stormwater retention pond to southwest of subject property, adjacent to North Island Highway (June 2020).

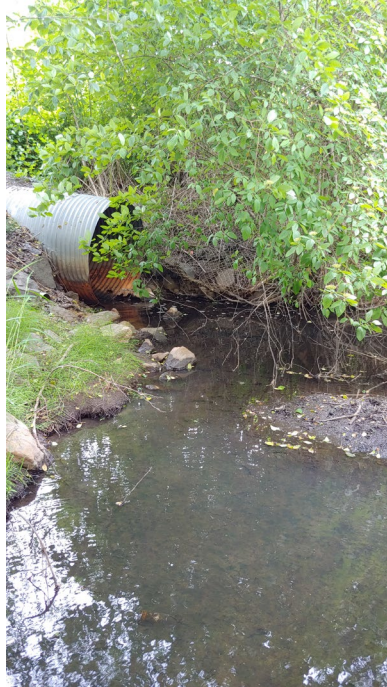
Photo 8. Culvert running south beneath subject property, through which Stream 2 flows southwest. Photo taken from Stream 1, which flows northeast toward culvert (June 2020).

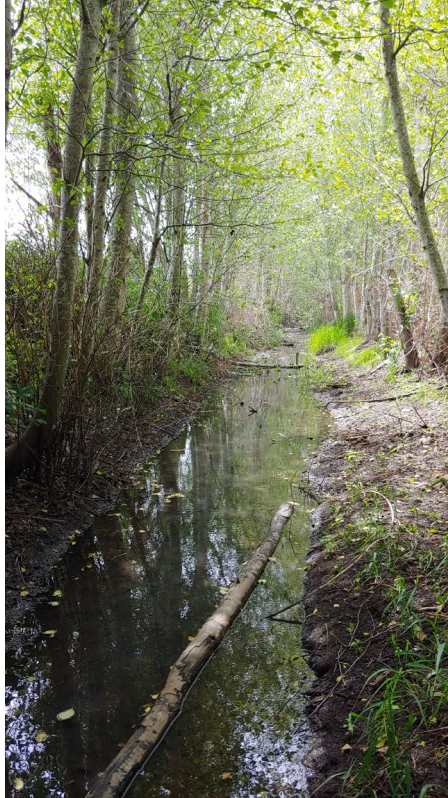
Photo 9. Stream 1 looking northeast toward culvert showing straight and homogeneous channel with muddy substrates (June 2020).

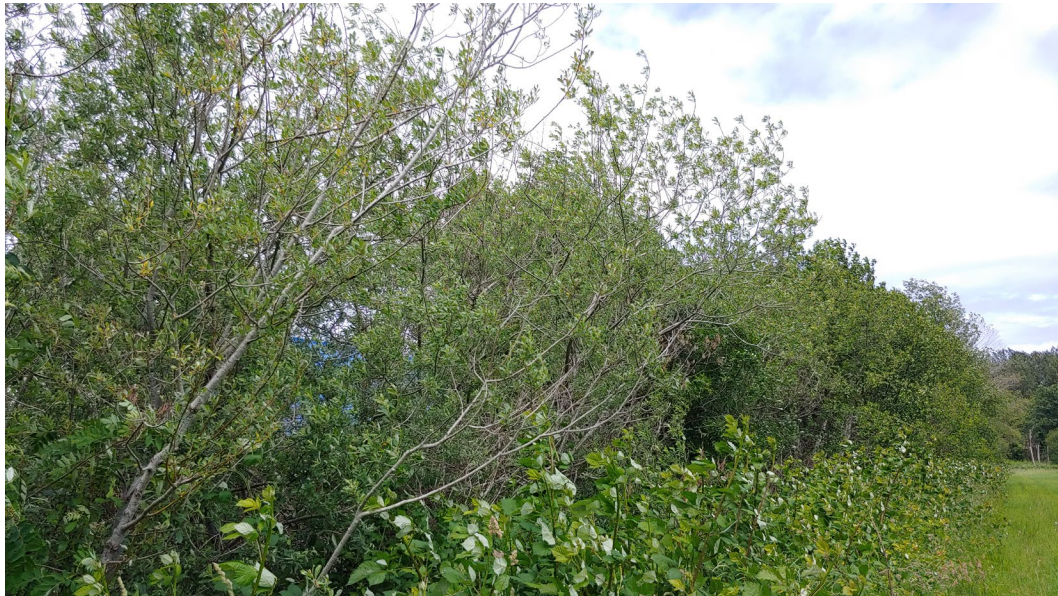
Photo 10. Riparian vegetation (Himalayan blackberry, red alder, and Pacific willow) along right bank of Stream 1, looking northeast. Photo taken from agricultural property to south of subject property (June 2020).

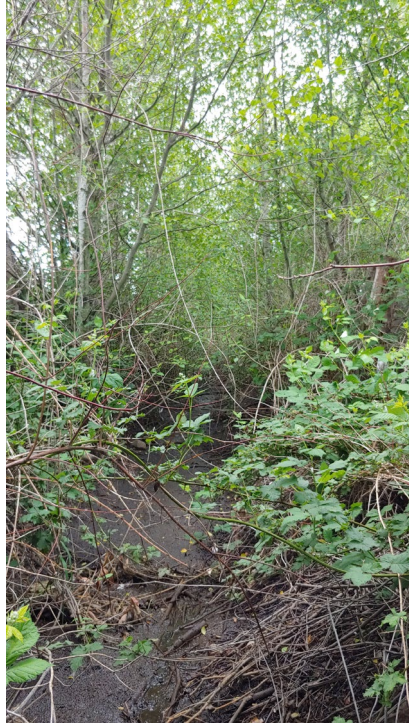
Stream 1 was dry during the site visit from CoC's stormwater retention pond until approximately 60 m upstream of Stream 2, where shallow water appeared with trace surface flow. It is a channelized watercourse, with fine silt/mud substrates with stagnant and seasonal hydrology (Photo 9). The channel is homogenous and lacks pools, in-stream large woody debris and spawning gravels, therefore it is poor fish habitat. While no fish were observed at the time of this survey we have observed rearing juveniles in this reach during previous surveys in late winter for CoC. There were several areas with undercut banks. The riparian vegetation is dominated by red alder (*Alnus rubra*), Pacific willow (*Salix lucida*), and red-osier dogwood (*Cornus sericea*) along both banks (Photo 10). Invasive species observed included Himalayan blackberry (*Rubus armeniacus*) and English holly (*Ilex aquifolium*, Photo 10). The stream is overgrown with Himalayan blackberry, with canes across much of the channel (Photo 11). The left bank of Stream 1 was armoured with riprap adjacent to the culvert.

Photo 11. Dry portion of Stream 1 looking southwest toward retention pond, showing Himalayan blackberry covering channel (June 2020).

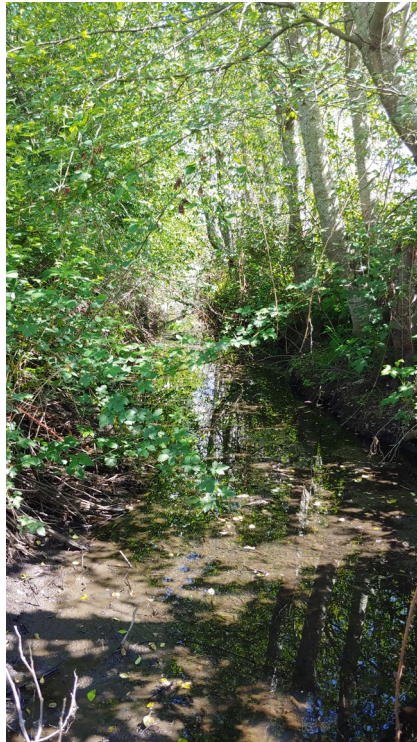
Photo 12. Stream 2 looking south showing straight and homogeneous channel overgrown with Himalayan blackberry. Red alder observed along banks (June 2020).

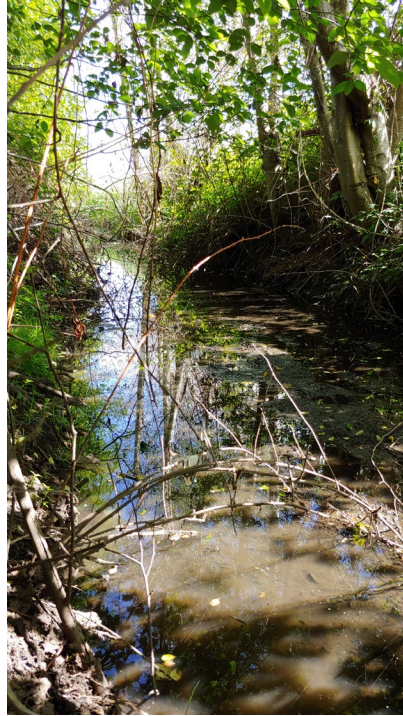
Photo 13. Stream 2 looking south showing straight and homogeneous channel overgrown with Himalayan blackberry. Red alder observed along banks (June 2020).

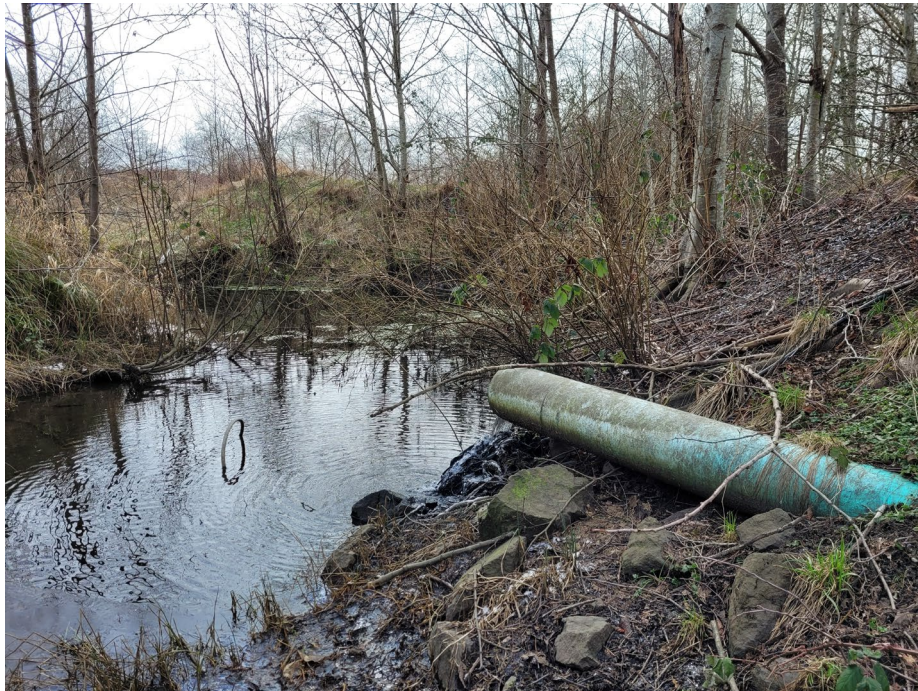
Photo 14. Pipe in the northwest corner of Len's pond that diverts overflow water from the culvert beneath 801 Ryan Road into the pond (February 2021).

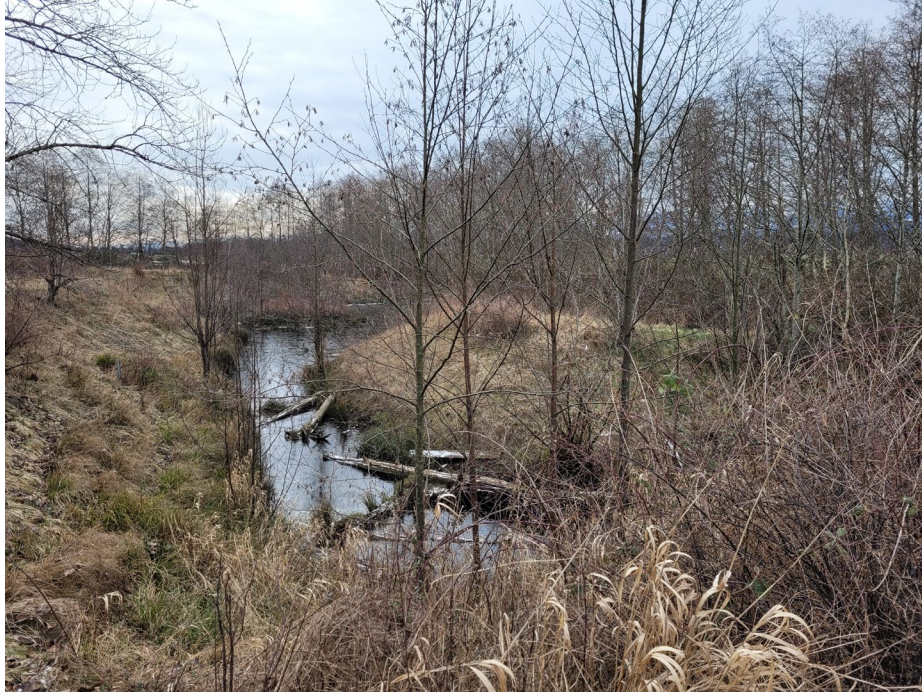
Photo 15. Len's pond looking southwest, with steep defined banks and minimal riparian vegetation (February 2021).

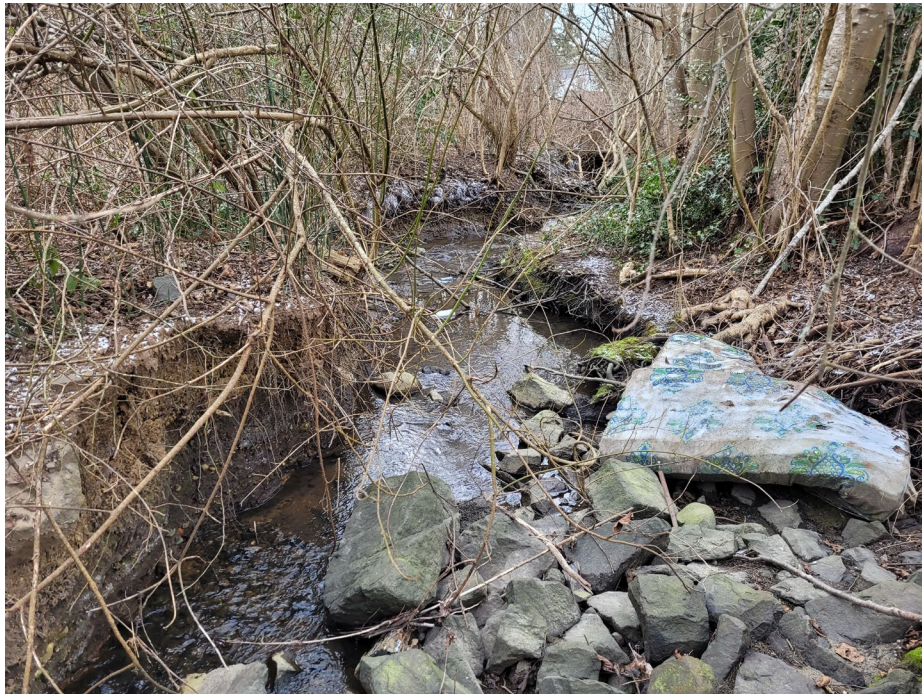
Bonner Creek is a tributary to Glen Urquhart Creek, flowing through residential areas before joining with Glen Urquhart Creek southeast of the subject properties. The creek has steep eroded banks, with exposed roots and undercut banks (Photo 16), indicating the flashiness of the urban creek. The substrate is composed of hardpan along the banks (Photo 17) and stream bed, silt, and cobbles/boulders. Small patches of gravels were observed within the reach. Riparian vegetation was predominantly deciduous, with the dominant tree species being red alder and black cottonwood. Horsetail, slough sedge, sword fern, and trailing blackberry are present along the banks, and much of the surveyed reach was covered in overhanging Pacific ninebark (Photos 16 and 17). Invasive species such as Himalayan Blackberry and English holly were present within the riparian area (Photo 17). The creek flows through a 2.2 m diameter corrugated steel culvert beneath a walking path leading to Williams Road (Photo 18). Downstream of Williams Road, Bonner Creek flows beside houses with very limited left bank riparian cover including a Western red cedar, nooka rose, English ivy, and Himalayan Blackberry (Photo 19). The left bank of the creek in this residential area is armoured with riprap and retaining walls (Photo 19). Multiple drainage pipes were observed spilling water into the creek throughout the surveyed reach. Debris such as tires and mattress were observed within the creek (Photo 16). Several pools were noted throughout the surveyed reach, with a moderate amount of large woody debris in the channel.

Photo 16. Looking downstream in Bonner Creek, showing eroded banks with exposed roots and undercut banks along left bank. Debris observed within channel (February 2021).

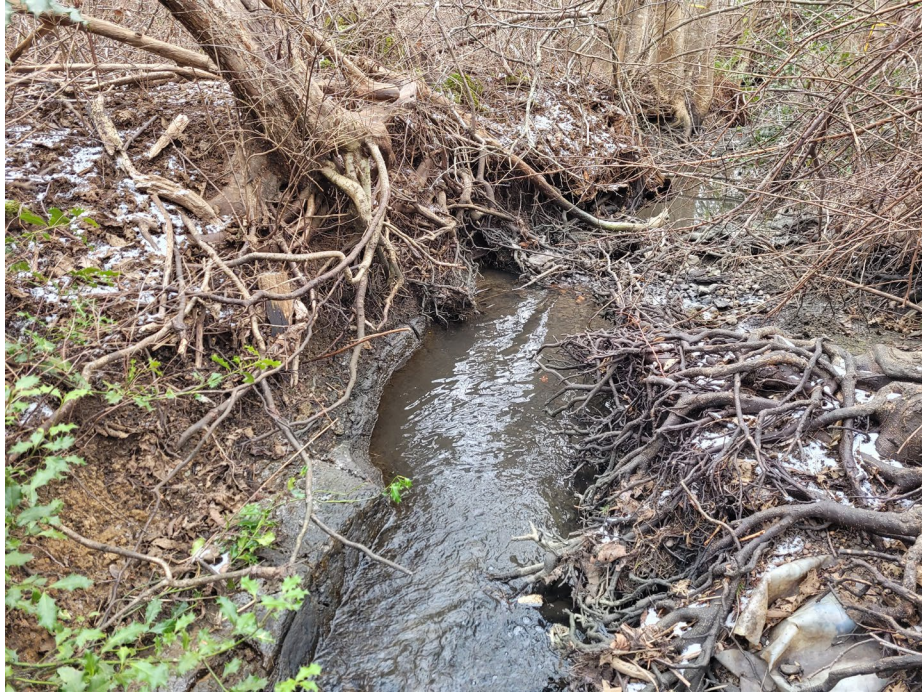
Photo 17. Hardpan along banks of Bonner Creek, with exposed tree roots due to erosion. Cobbles and sand/silt within this reach (February 2021).

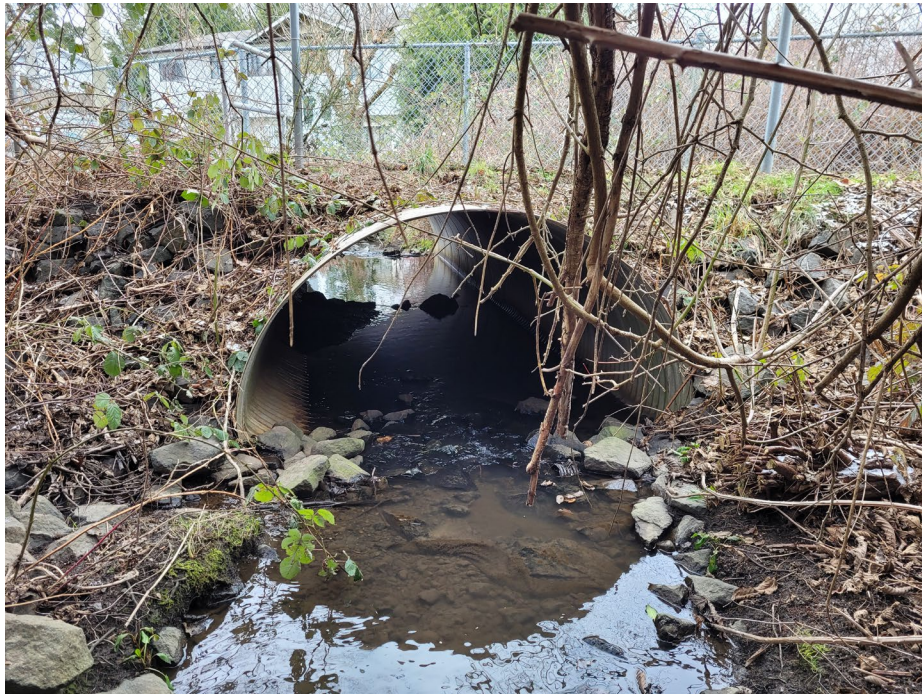
Photo 18. Bonner Creek flows through a 2.2 diameter CSP culvert beneath walking path to Williams Road, looking downstream (February 2021).

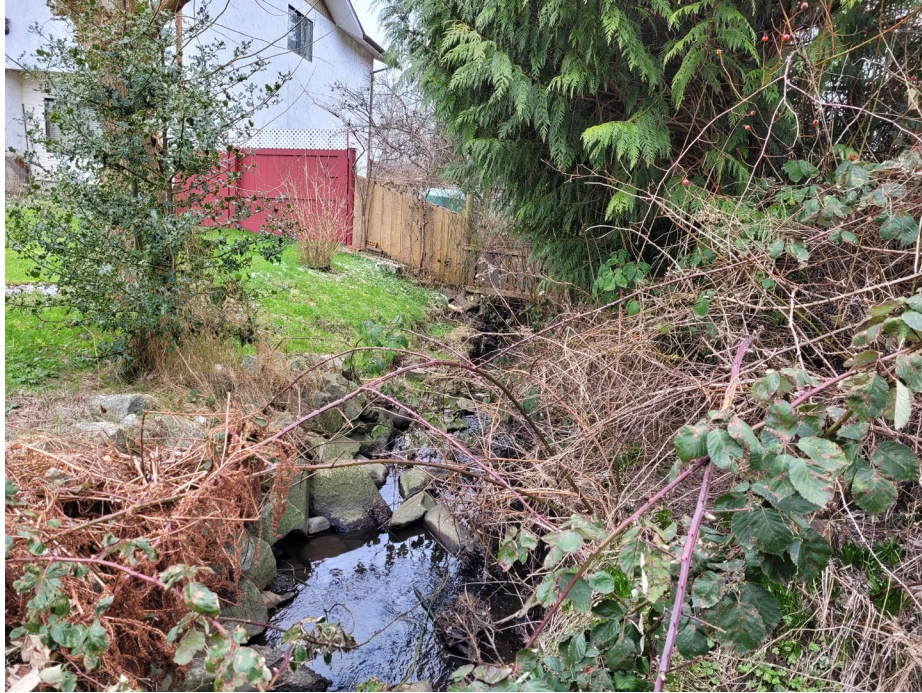
Photo 19. Bonner Creek downstream of 2.2 m diameter culvert. Creek flows beside residential properties and has armoured banks (February 2021).

The left bank of Stream 1 was armoured with riprap adjacent to the culvert, therefore they may be stability concerns in this location of Stream 1. The left bank of Bonner Creek in the reach adjacent to the residential properties was also armoured with rip rap and retaining walls. As such, it is important that no trees are removed from the 10.9 m SPEA of Stream 1 or the 10 m SPEA of Bonner Creek. There were no slope stability issues noted along Stream 2 or for the remaining Stream 1 reach to the southwest of the culvert.

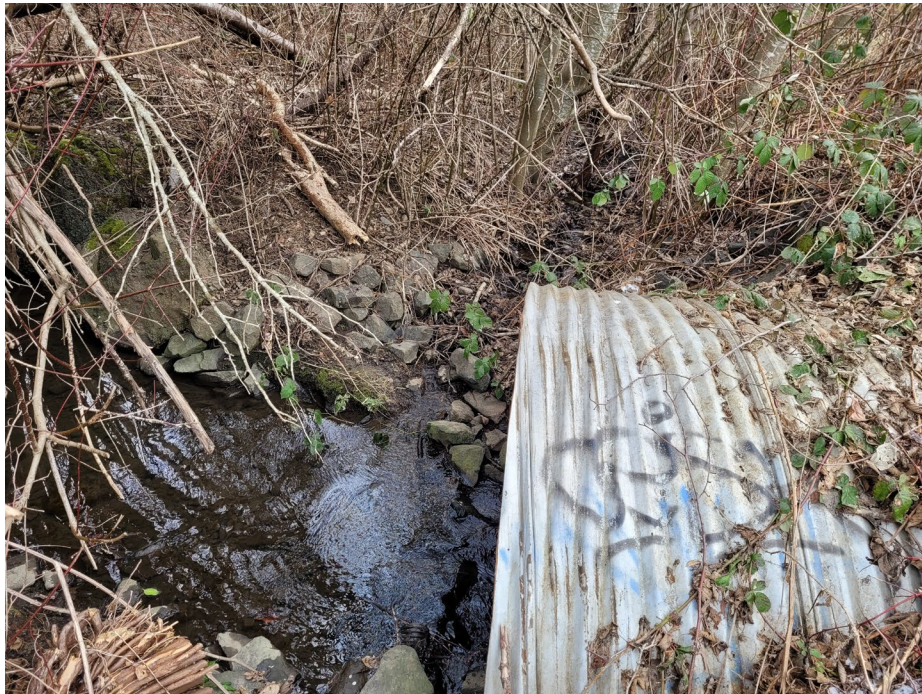
A drainage ditch flows into the left bank of Bonner Creek at the upstream end of the culvert beneath the walking path (Photo 20). This ditch follows the fence line to the east (Photo 21), beside residential properties. Due to access issues, the headwaters of the ditch are unknown, however a pipe beneath a property to the east was observed spilling water into the channel (Photo 22), therefore it likely serves as a stormwater overflow channel, contributing flow to Bonner Creek. The area surrounding this pipe was wet with trace flows from the northeast (Photo 23).

Photo 20. Drainage ditch (Ditch 1) flowing into Bonner Creek from left bank (February 2021).

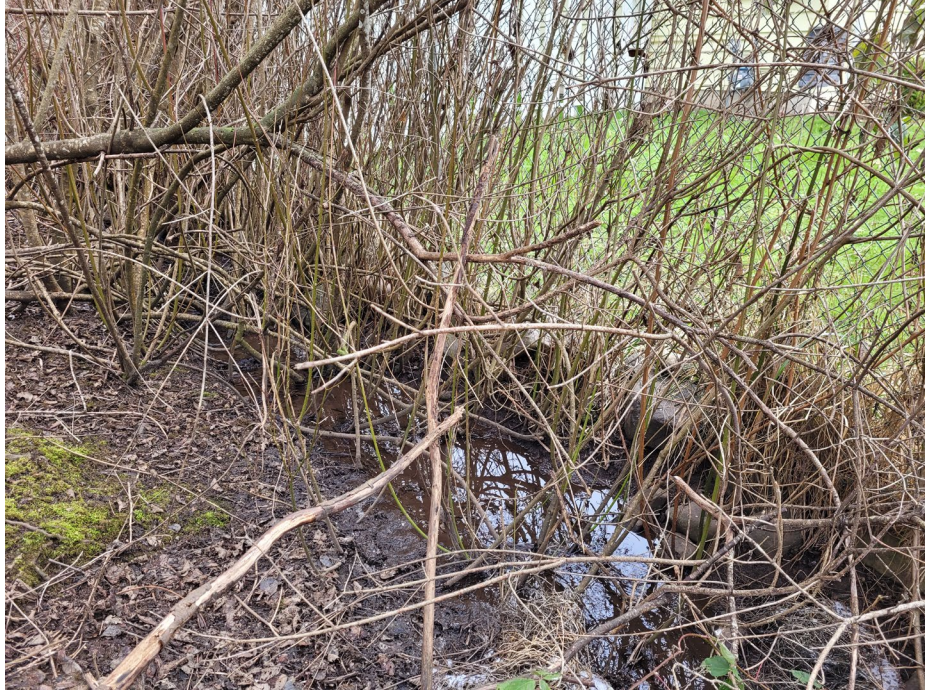
Photo 21. Ditch 1 flowing along fence line to the southeast of Bonner Creek (February 2021).

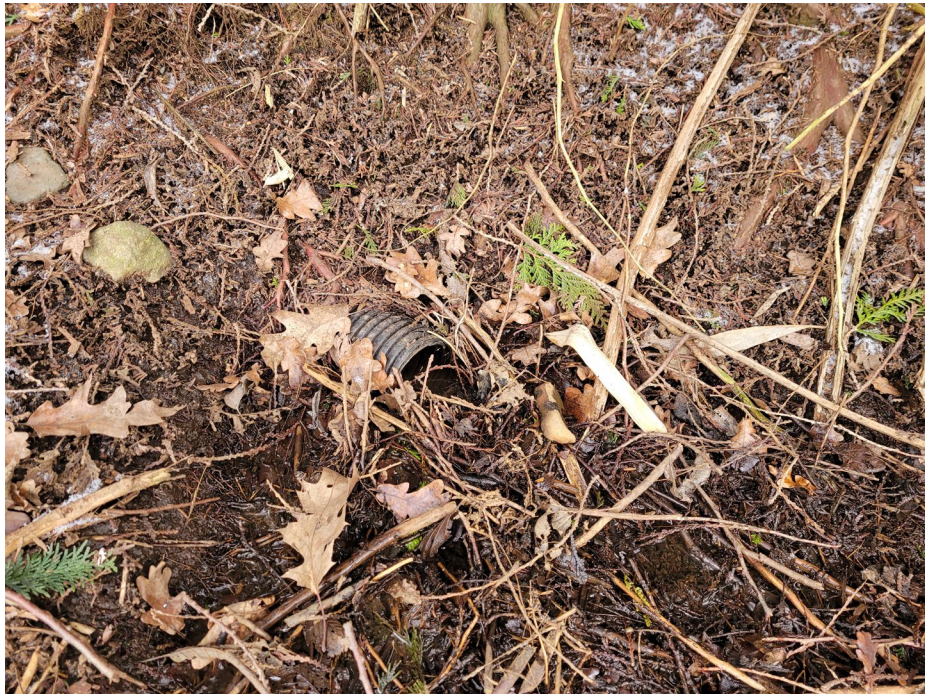
Photo 22. Pipe beneath residential property contributing flow to Ditch 1 (February 2021).

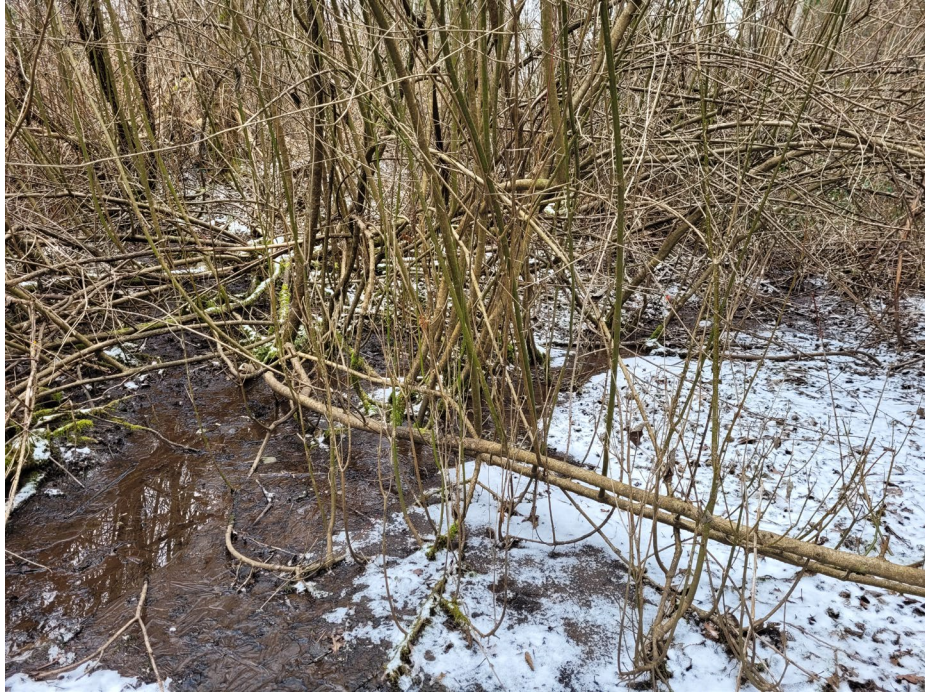
Photo 23. Wet area with trace flows beneath Bonner Creek and Ditch 1 (February 2021).

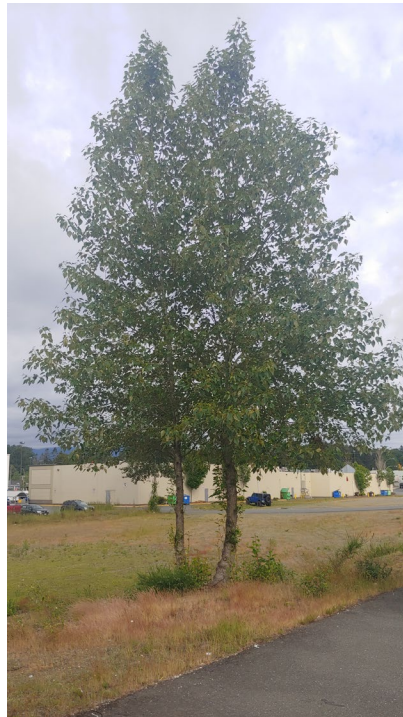
Photo 24. Small black cottonwood trees between the paved and unpaved portion of the subject property, north of Streams 1 and 2.

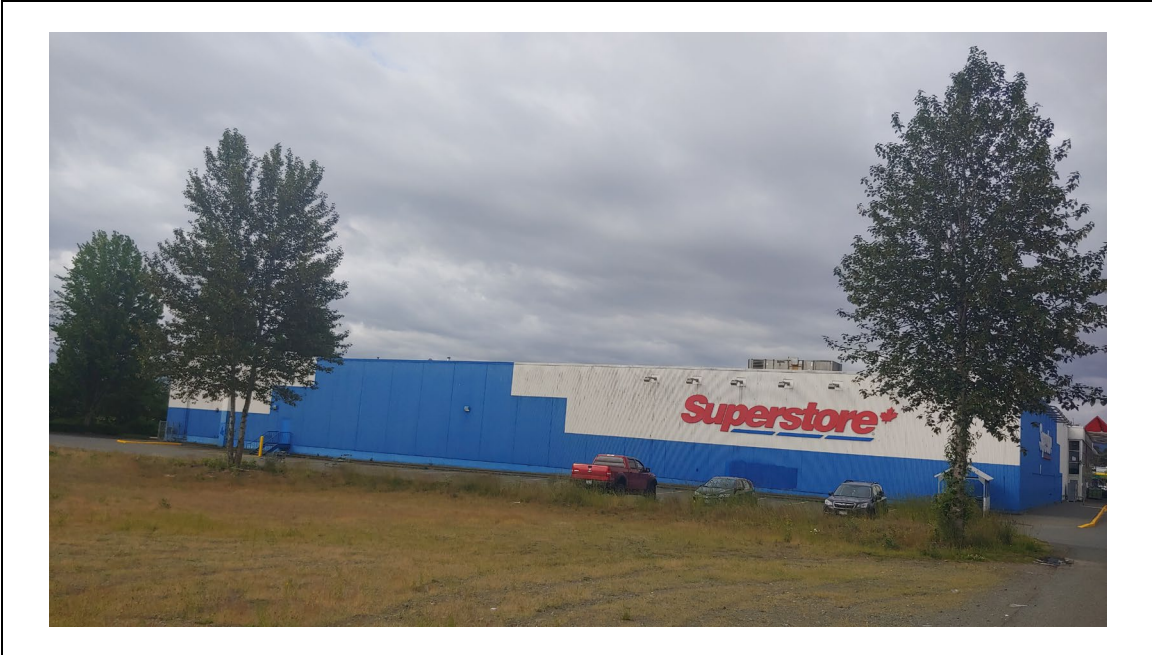
Photo 25. Mature black cottonwood trees between western portion of subject property and Superstore.
